# **Imperiled Community Water Resources Analysis**

**Immediate Action Workgroup  
An Advisory Group of the Governor's Climate  
Change Sub-Cabinet**

**June 30, 2010**

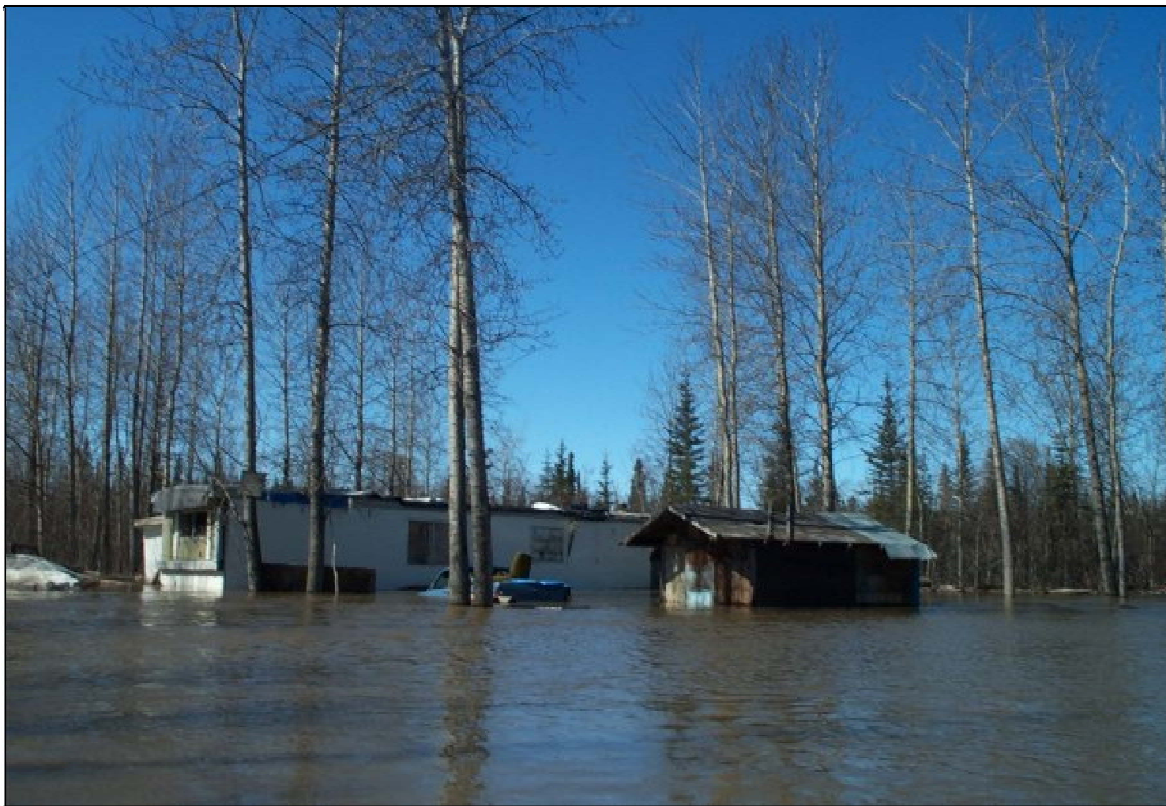
Coastal and riverine erosion can structurally undermine water and wastewater infrastructure, and also make communities and their infrastructure systems more susceptible to flooding (Figure 14). Erosion can adversely affect source water quality because of increased sedimentation and/or saltwater inundation and intrusion.

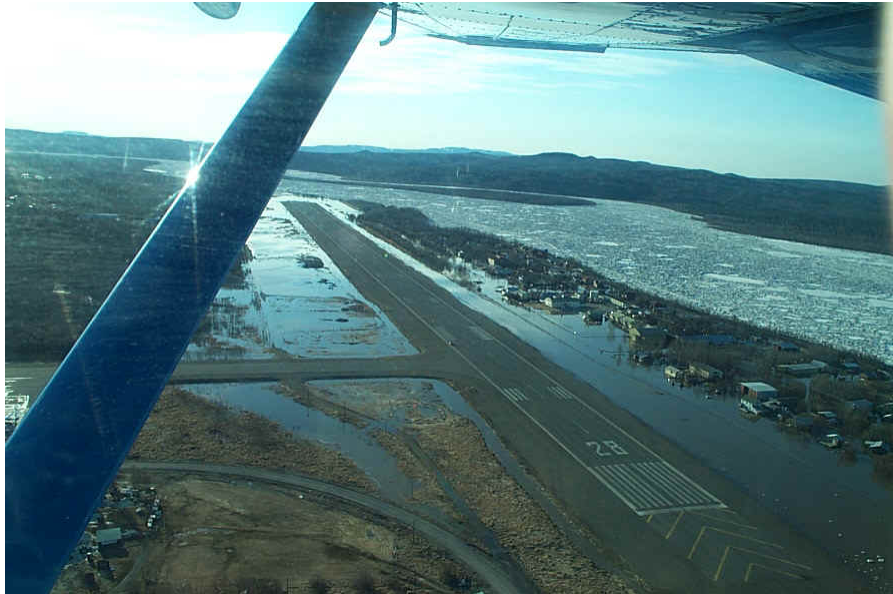
View from the air of Aniak flooding during the 2002 flood event. Old Aniak is between the airport and the ice-jammed Kuskokwim River. Photo courtesy of the Division of Homeland Security and Emergency Management.

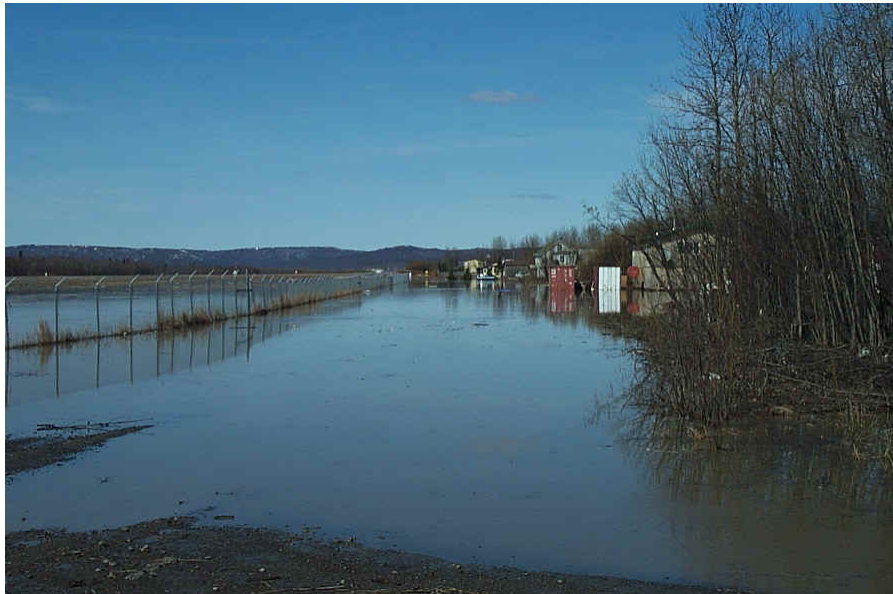
View from the ground looking during 2002 flooding. Old Aniak is to the right, and the airport to the left in this photo courtesy of the Division of Homeland Security and Emergency Management.

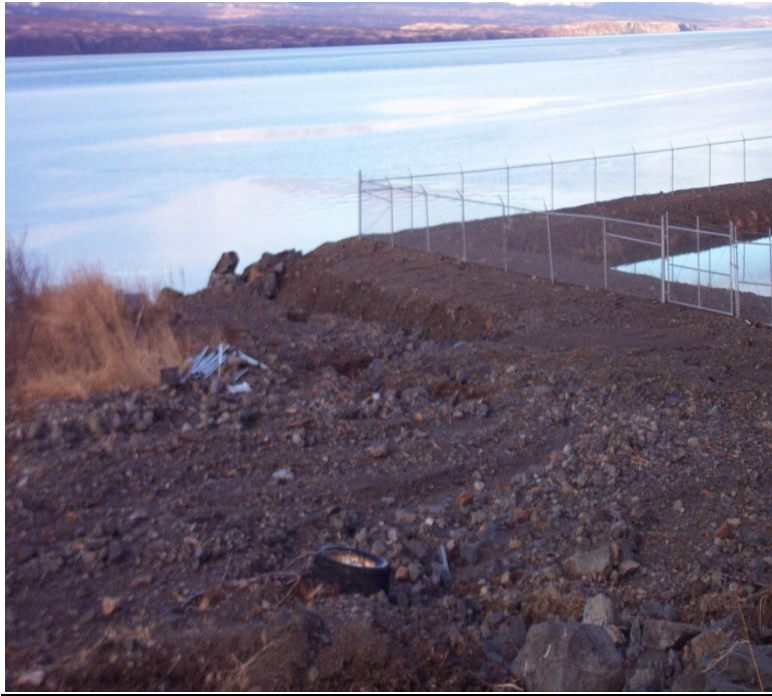
**Erosion around the perimeter of the Chignik Lagoon sewage lagoon caused by flooding. Photo taken January 29, 2003 courtesy of Lake and Peninsula Borough.**

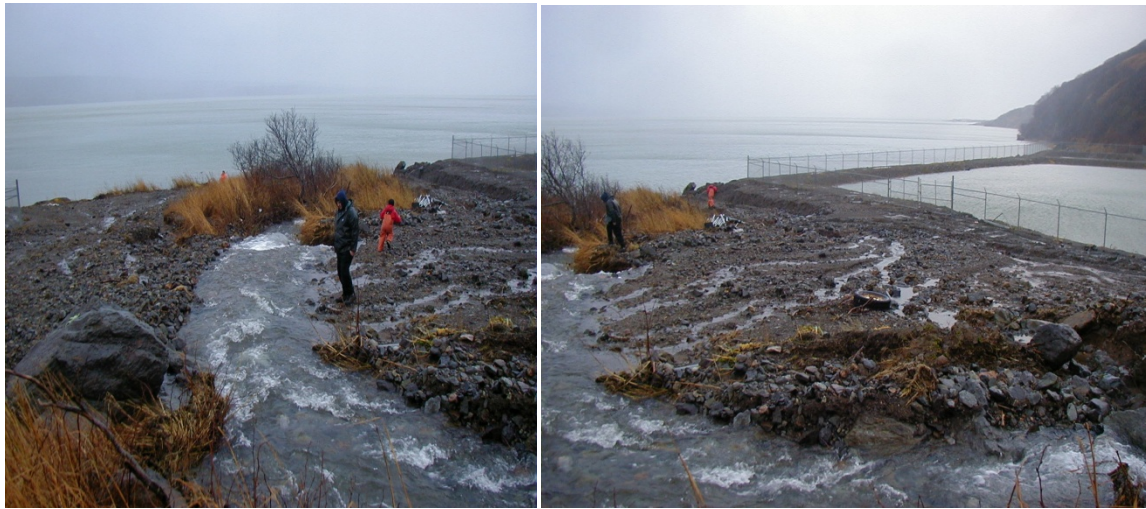
**An overflow channel of Packer Creek cuts past the sewage lagoon during January, 2003 flooding. Photo courtesy of Lake and Peninsula Borough**

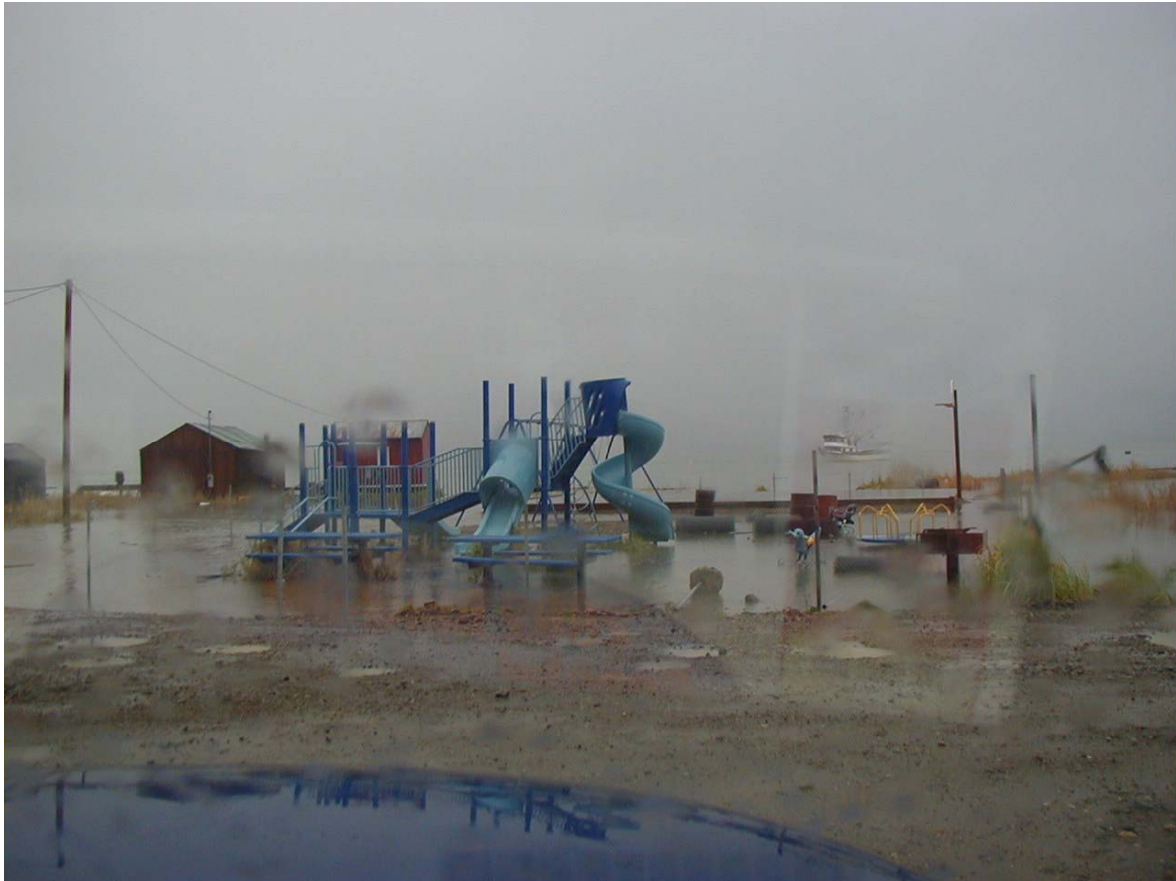
**Playground awash during 2002 flooding at Chignik Lagoon. Photo courtesy of Lake and Peninsula Borough.**

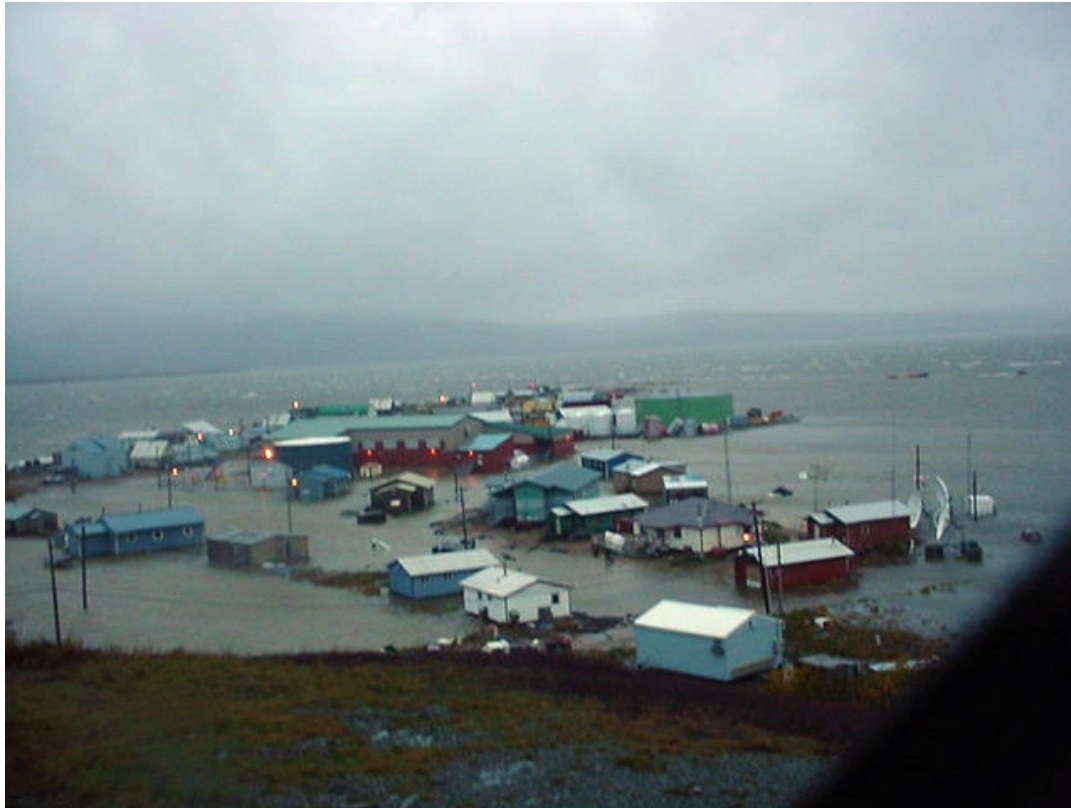
Golovin lower village during September 23, 2005 Bering Sea Storm. Photo Credit: City of Golovin, *Golovin Multi-Hazard Mitigation Plan*.

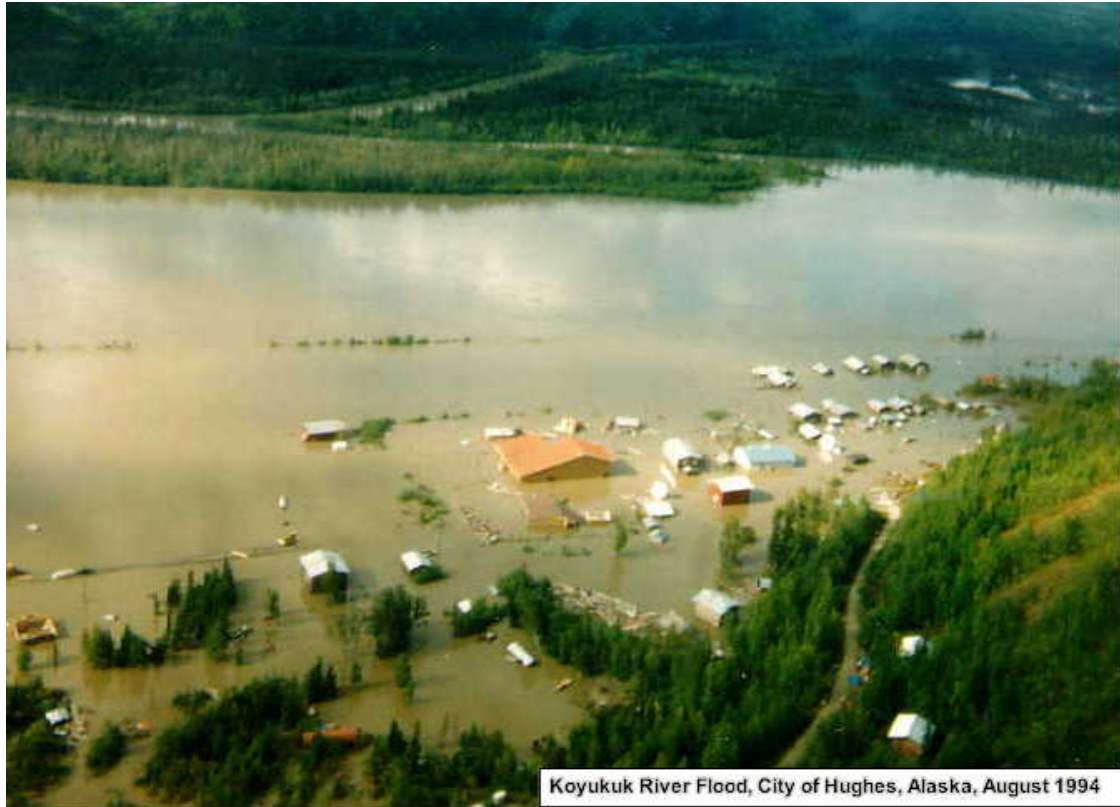
Koyukuk River Flood, City of Hughes, Alaska, August 1994

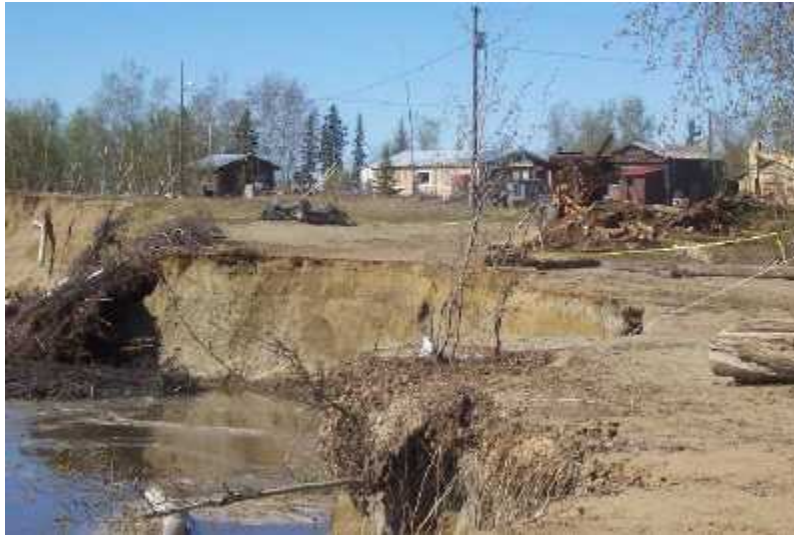
© Koyukuk River erosion in Huslia. This undated photo was provided by community residents and is courtesy of the DCRA online photo library. The Koyukuk River caused an additional 15 to 20 feet of erosion in 2009 according to ANTHC.

Past erosion control and bank stabilization efforts have been largely unsuccessful, whereas gradual relocation of homes and other threatened structures and infrastructure of value has been successful at avoiding losses. Moving away from the eroding Koyukuk River has also proven successful in avoiding loss to the bulk fuel facility in 1993. Some water service lines serving riverfront homes may need to be relocated as the river advances.

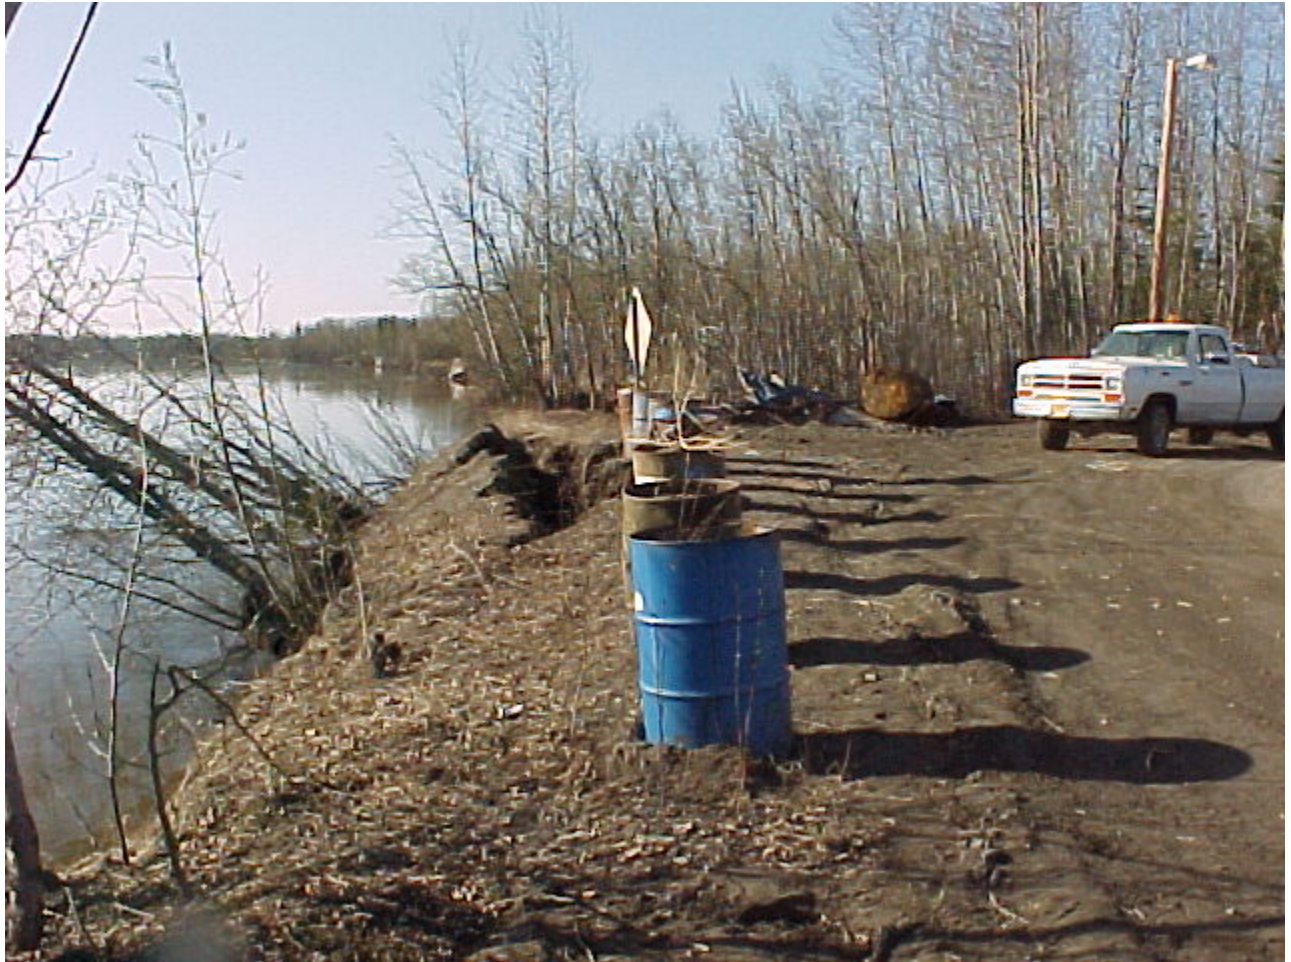
Erosion along Takotna Avenue May 2005. Photo courtesy Division of Homeland Security and Emergency Management

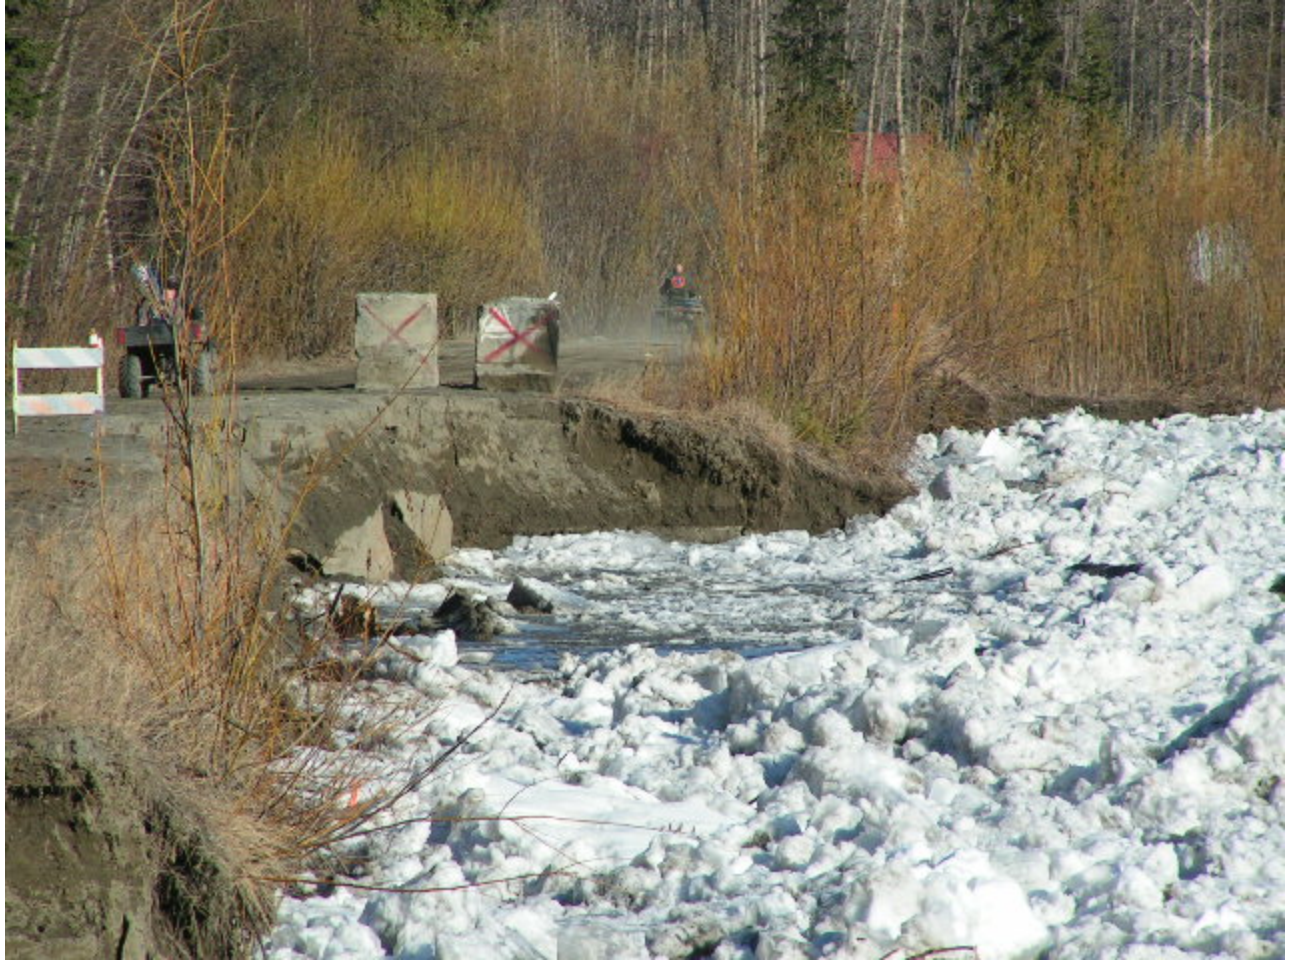
Friday, May 12, 2006 Takotna Avenue closed near log haul. Photo courtesy of Natalie Baumgartner.

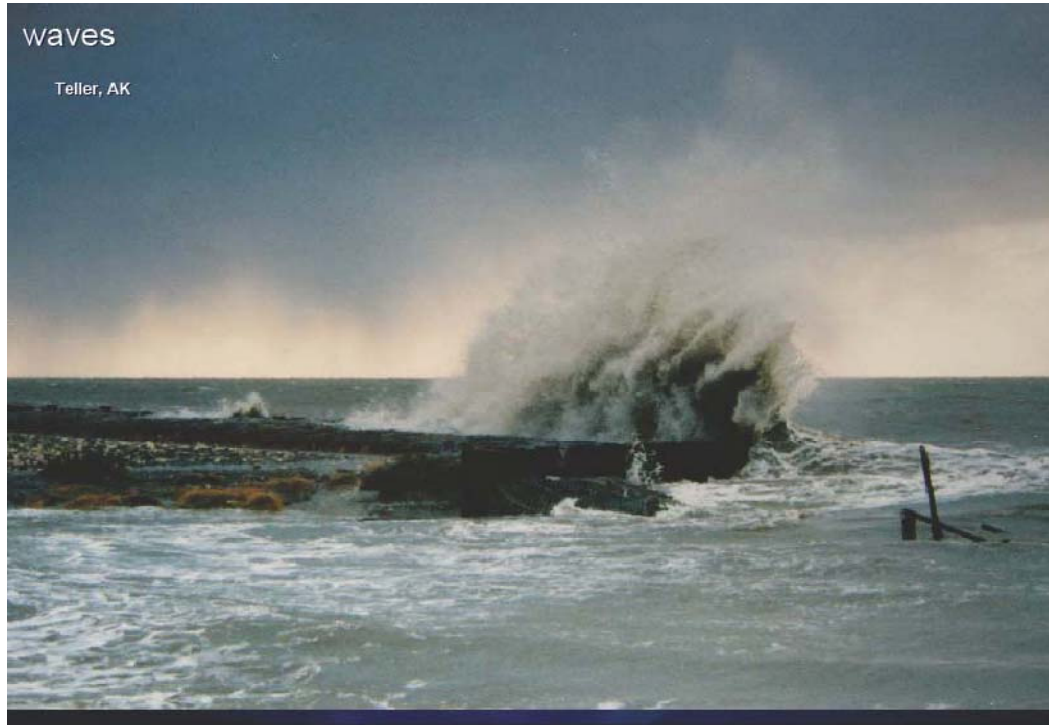
Waves hitting Teller seawall, the sewage lagoon that serves the school is to the left out of view of this photo; photo courtesy of David E. Atkinson, University of Alaska Fairbanks, International Arctic Research Center, (2007).
