**Greater Kuparuk Area (GKA)  
Western North Slope (WNS)  
Corrosion Programs Overview**

**March 31, 2006**

***Commitment to Corrosion Monitoring***  
***6<sup>th</sup> Annual Report to the Alaska Department of Environmental Conservation***

Prepared by  
**ConocoPhillips Corrosion Team**

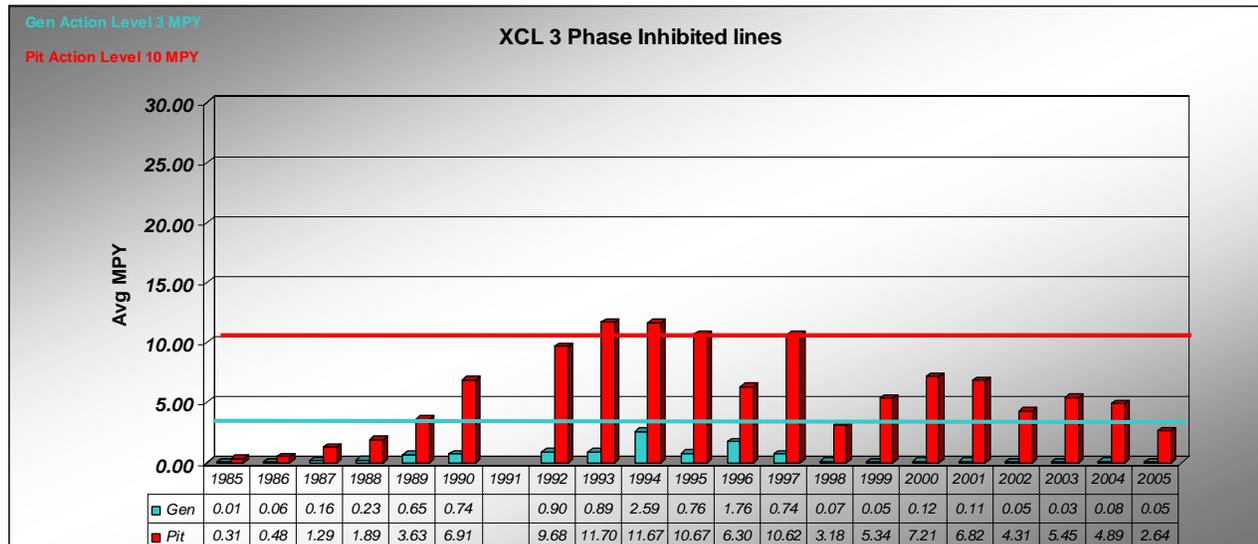
**Figure 1. Three-phase Production Cross-Country Line Coupons – general and pitting corrosion rates as a function of time.**

*Three-phase Production Cross-Country Lines:* The monitoring data summarized in Kugaruk Tables 1 and 2 and presented in Figure 1 suggest that general corrosion is under control. The data presented in Tables 1 and 2 and in Figure 1 include corrosion coupon data from the wet oil lines starting at CPF3 and going to CPF1 and CPF2.

Where corrosion rates exceeded targets, corrosion inhibitor concentrations were increased and/or the amount of inspection was increased. In 2005, coupon, probe or inspection-based corrosion rates exceeded targets or revealed increased damage on eight lines. In 2005, inspection results indicated minor corrosion had occurred in four of these eight lines. A complete listing of the lines with coupon/probe corrosion rates that exceeded targets and/or where inspection indicated increased damage is given in Table 3.

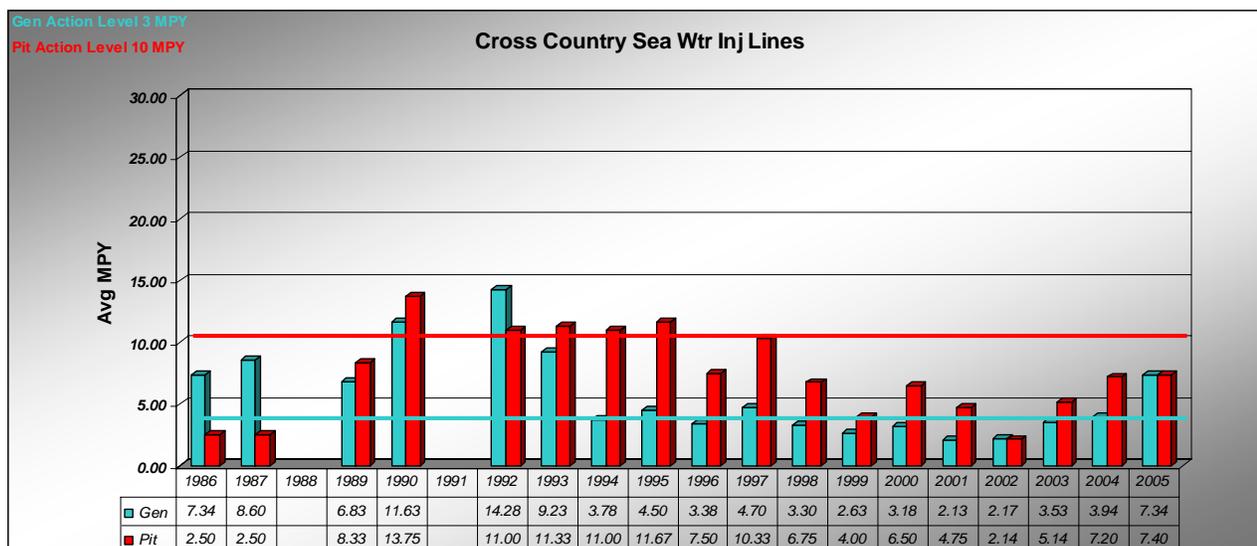
**Figure 2. Seawater Cross-Country Line Coupons – general and pitting corrosion rates as a function of time.**

*Sea Water Cross-Country Lines:* The monitoring data summarized in Kuparuk Tables 1 and 2 and presented in Figure 2 above, show the average corrosion rates for the sea water cross-country line coupons. Higher coupon corrosion rates were caused by higher dissolved oxygen concentrations seen during 2005 break-up and oxygen scavenger was added to decrease the dissolved oxygen concentration; these coupons are located near the exit of the sea water treatment plant (STP) and are not believed to be indicative of corrosion in the sea water injection system. Increased coupon corrosion rates detected are currently under review, with biocide concentration and pigging frequency increased in early 2006. Smart pigging of the 30-inch sea water line from the STP to the CW Skid is planned for 2006.

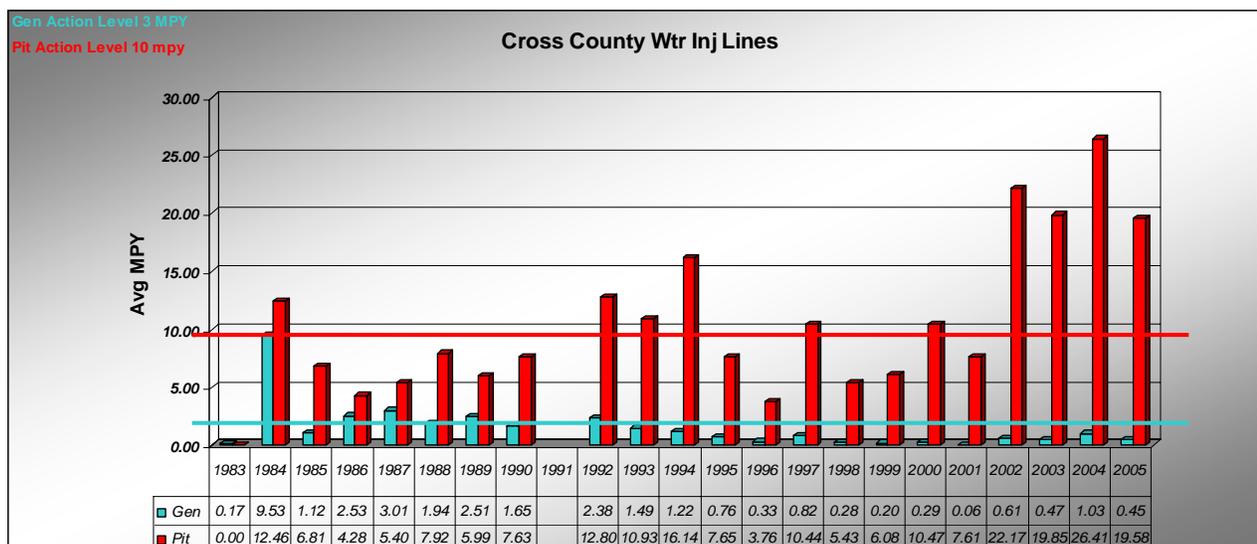
**Figure 3. Water Injection Cross-Country Line Coupons – general and pitting corrosion rates as a function of time.**

*Water Injection Cross-Country Lines:* The monitoring data summarized in Kuparuk Tables 1 and 2 and presented in Figure 3 show that average general corrosion rates are below the threshold, but that pitting rates for the field are above the threshold. Seawater and produced water commingling was suspended at CPF2 in August 2005 and coupons replaced then; coupons were retrieved from CPF2 in late November with pitting rates reduced markedly from previous pulls. Coupon results are used to prioritize inspection efforts. During 2005 additional equipment was installed and procedures were implemented to provide enhanced biocide treatments at CPF2. Cleaning pigs were upgraded to include brushes in addition to the disks and the pigging procedures changed to included multiple (three) pig runs per monthly cleaning cycle.

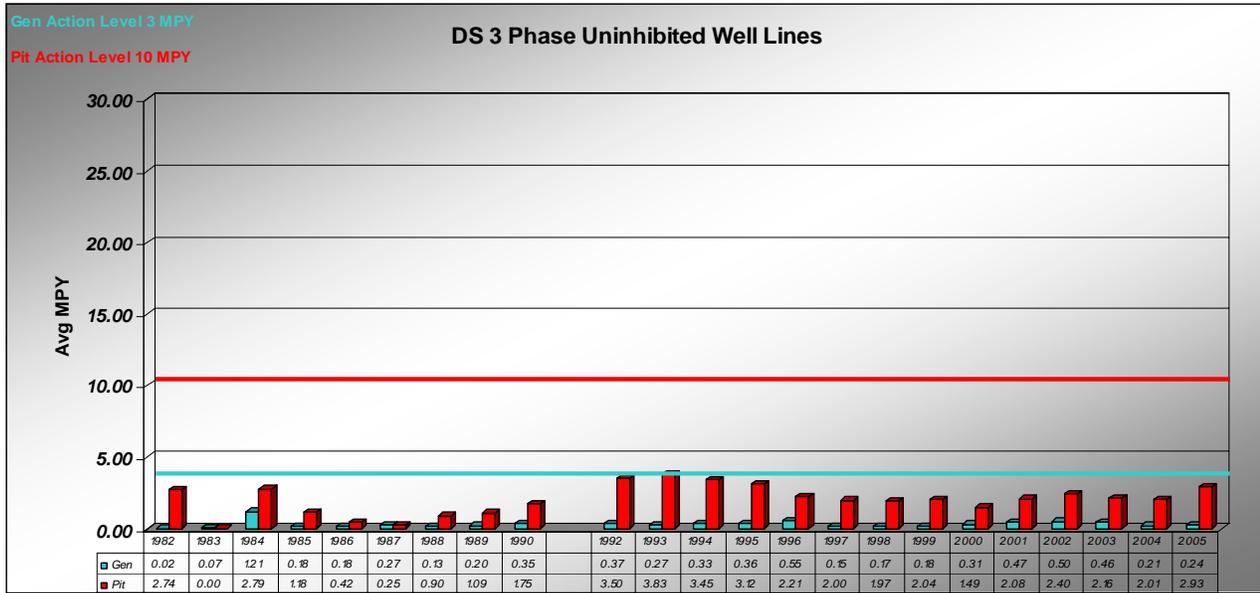
**Figure 4. Three-phase Production Well Line Coupons – general and pitting corrosion rates as a function of time.**

*Three-phase Production Well Flow Lines:* While the monitoring data summarized in Kuparuk Tables 1 and 2 and presented in Figures 4 and 5 suggest that corrosion rates are below targets, inspection data indicate that higher corrosion rates have been experienced historically. The well line inspection data are discussed in section 3.1.b below, and are a good example of why monitoring data alone cannot be relied upon to characterize corrosion in a given system. For three-phase production, coupons monitor free flowing fluid and have not shown the predominant, under-deposit corrosion mechanism.

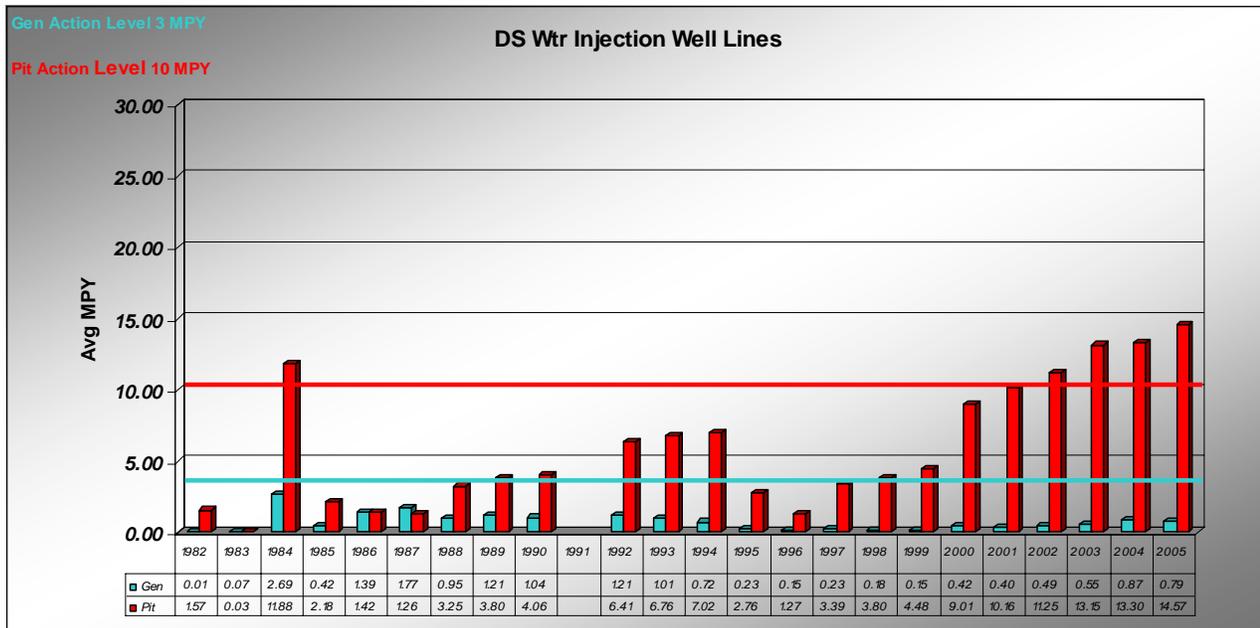
**Figure 5. Water Injection Well Line Coupons – general and pitting corrosion rates as a function of time.**

*Water Injection Well Flow Lines:* As discussed in section 3.1.b below, the well line inspection data on water injectors show that there are a significant number of corrosion related repairs. The water feeding this system is treated at the facilities with biocide and is discussed under Figure 3 - Water Injection Cross-Country Line Coupons. We believe that the increasing trend of coupon corrosion rates in the water injection well lines is caused by additional solids accumulating in the well lines because of low flow rates and improved pigging upstream of the well lines.

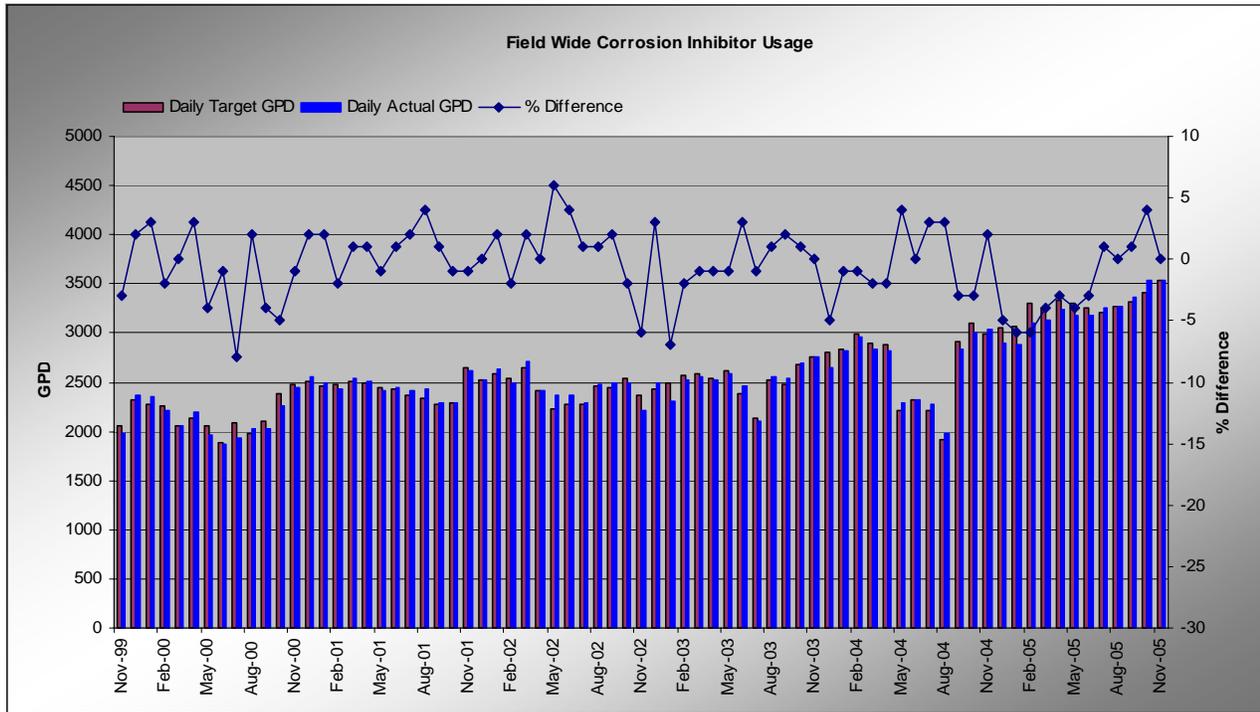
**Figure 6. Field-wide Corrosion Inhibitor Use.**

For the Kuparuk field, Figure 6 shows the actual number of gallons of corrosion inhibitor pumped per day, the recommended (target) number of gallons of corrosion inhibitor per day, and the percent difference between the two. The average deviation for the year was -1.85%. The large variation seen in the early parts of the year are usually caused by the extreme weather. Several pump upgrades were accomplished in 2005 to accommodate increased volumes.

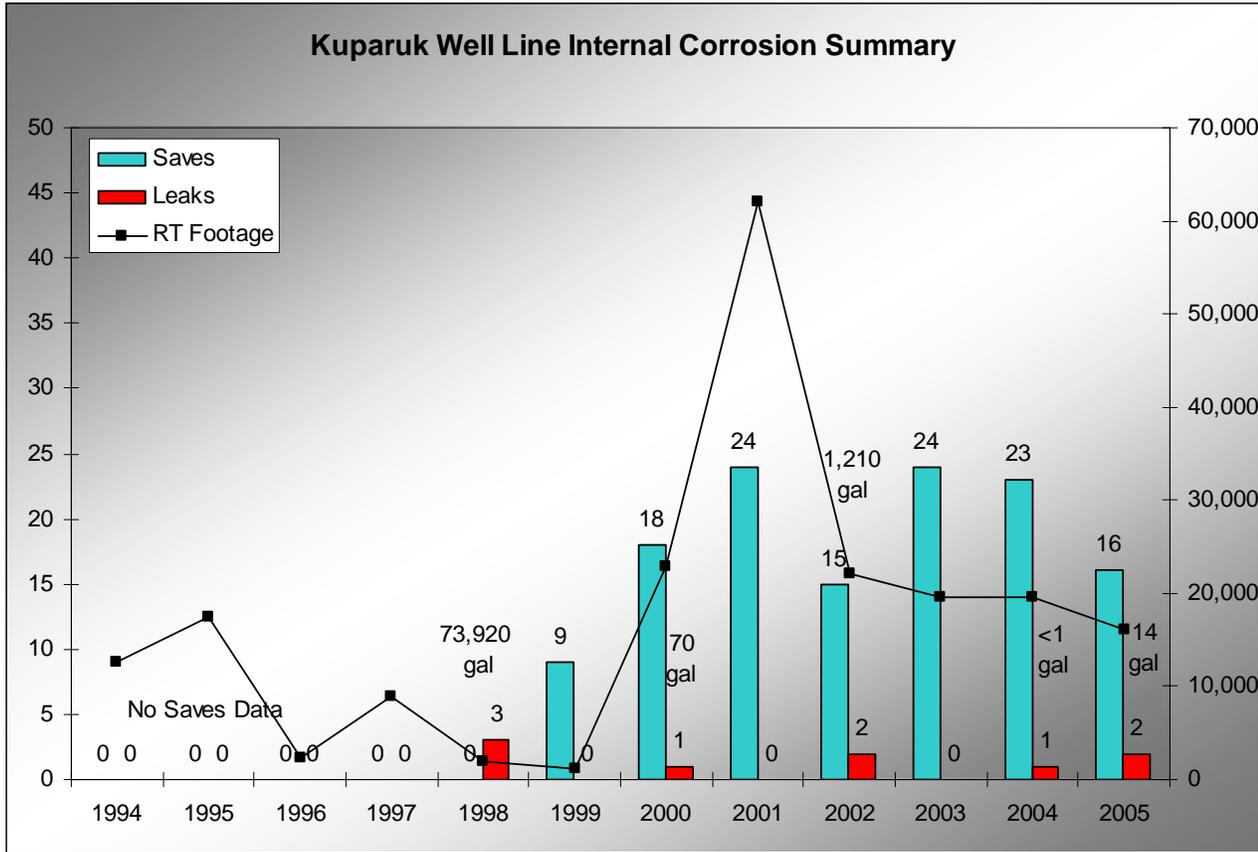
As indicated in Figure 8 below, repair recommendations were initiated on 18 well lines in 2005 because of internal corrosion or erosion damage (11 corroded water injection lines, 6 corroded production lines and 1 eroded production line). Except for the leak that was caused by erosion, the corrosion mechanisms were all underdeposit corrosion. More information on the leaks can be found in section 3.1.g.

**Figure 8. Summary of Well Line Internal Corrosion Inspections – RT footage, leaks, and saves as a function of time.**

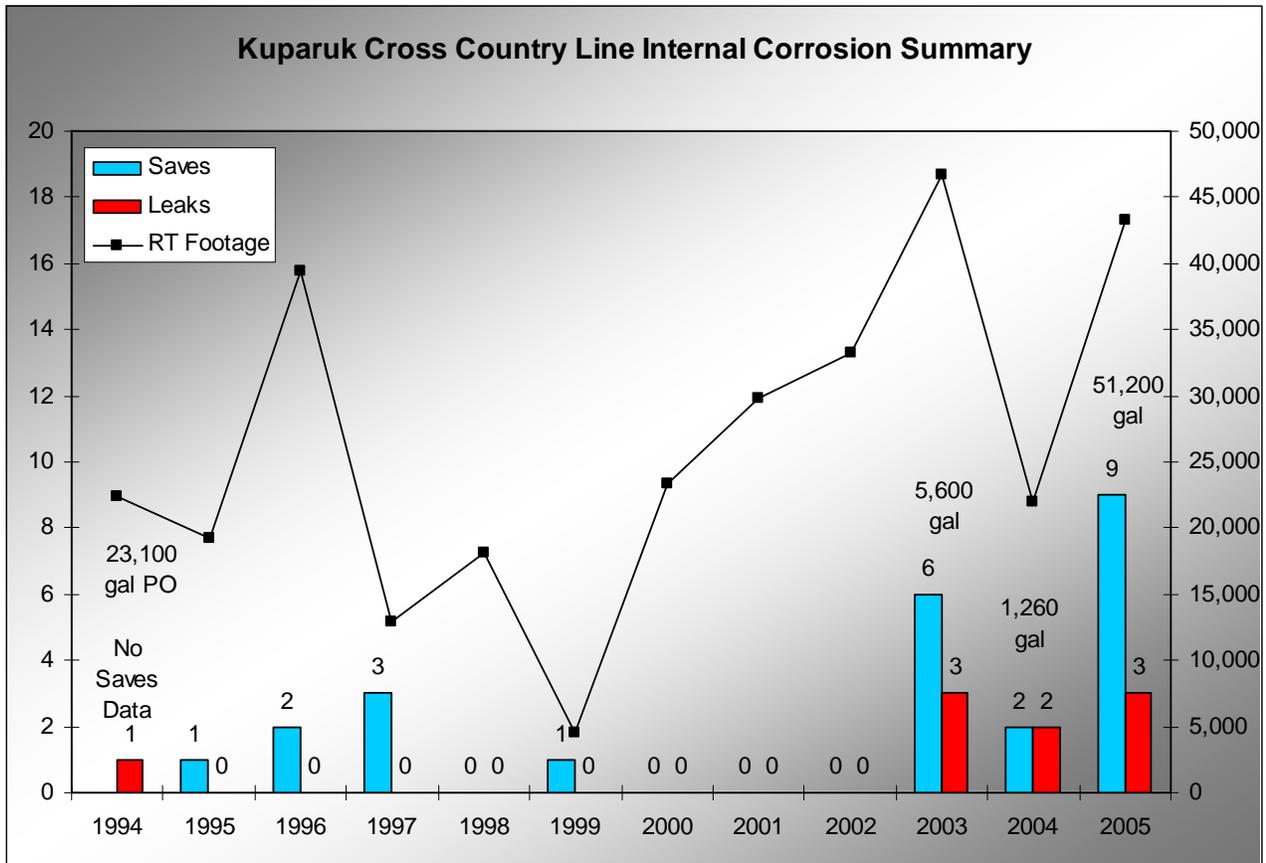
As indicated in Figure 9, 12 repair recommendations were initiated on cross-country lines (8 water injection, 4 production) because of internal corrosion damage in 2005. The corrosion mechanism for all repair recommendations was deadleg/underdeposit corrosion. All three leaks were in the water injection system. More information on the leaks can be found in section 3.1.g.

**Figure 9. Summary of Cross-Country Line Internal Corrosion Inspections – RT footage, leaks, and saves as a function of time.**

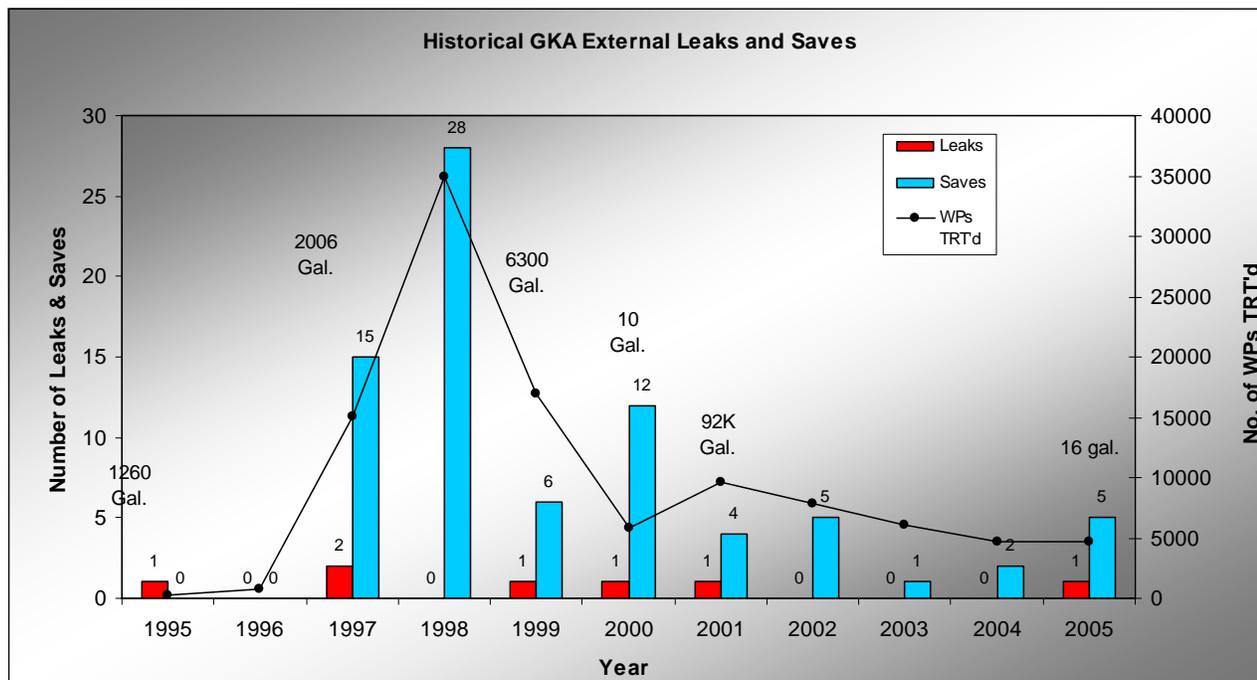
**Figure 10. Leaks, saves, number of weld packs inspected with TRT, and volumes of leaks as a function of time.**

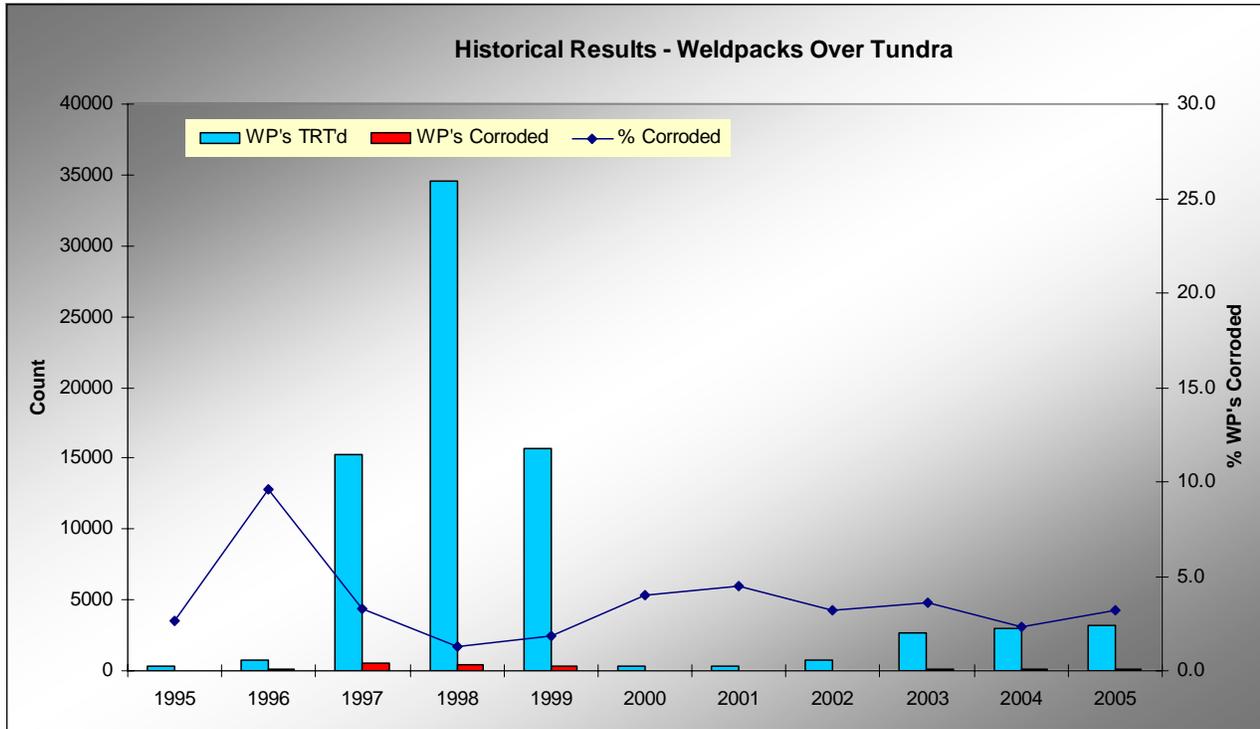
**Figure 11. Summary of Weld Packs on Cross-Country Lines over Tundra (off-pad).**

Figure 11 illustrates the most-complete external corrosion inspection program of the three external corrosion programs. 2002 through 2005 values include re-inspections and clean-up of locations missed or not properly documented during the original base line effort.

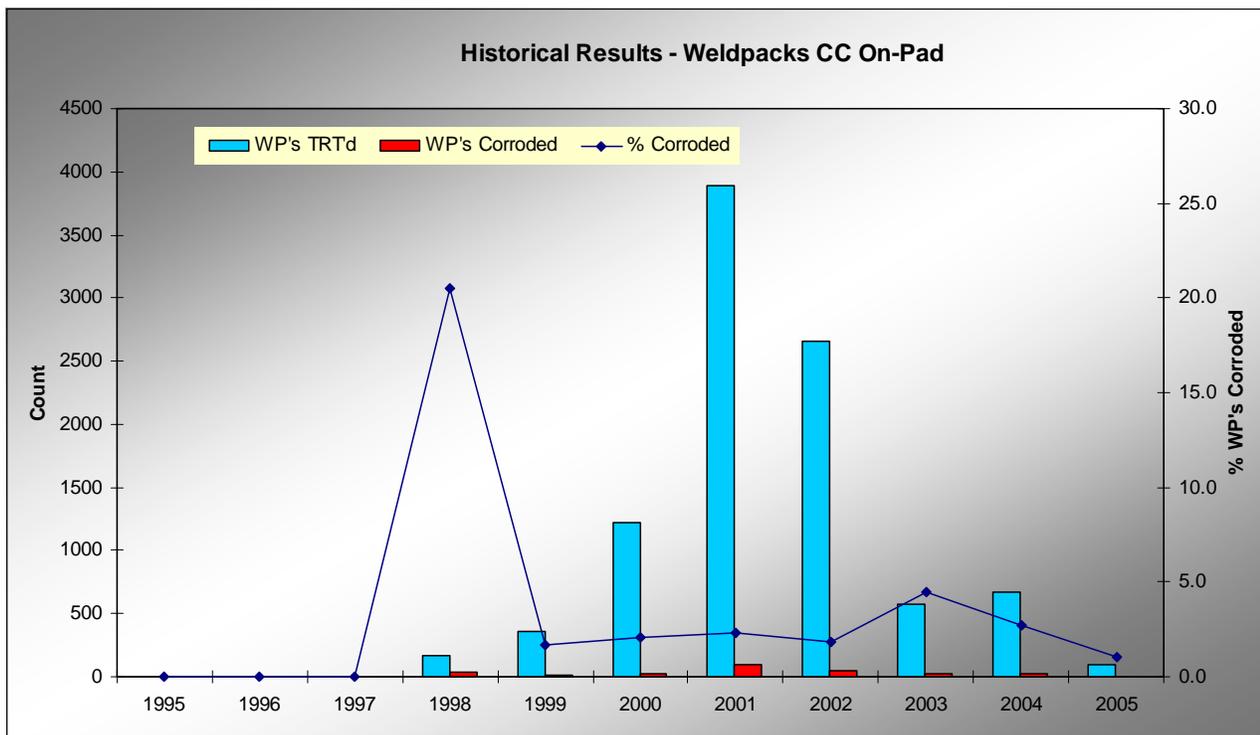
**Figure 12. Summary of Weld Packs on Cross-Country Lines on Pads.**

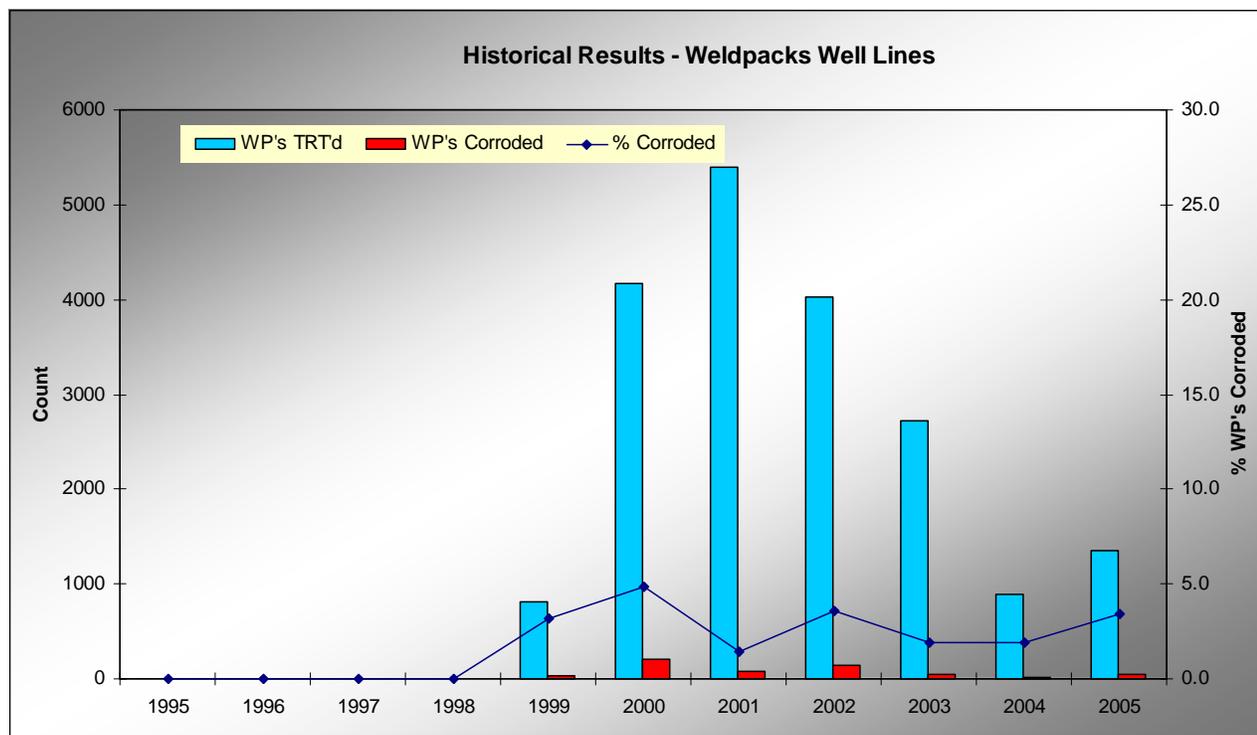
Figure 13. Summary of Weld Packs on Well Lines.
