**Greater Kuparuk Area (GKA)
Western North Slope (WNS)
Corrosion Programs Overview**

March 31, 2010

Commitment to Corrosion Monitoring
10th Annual Report to the Alaska Department of Environmental Conservation

Prepared by
ConocoPhillips Corrosion Team

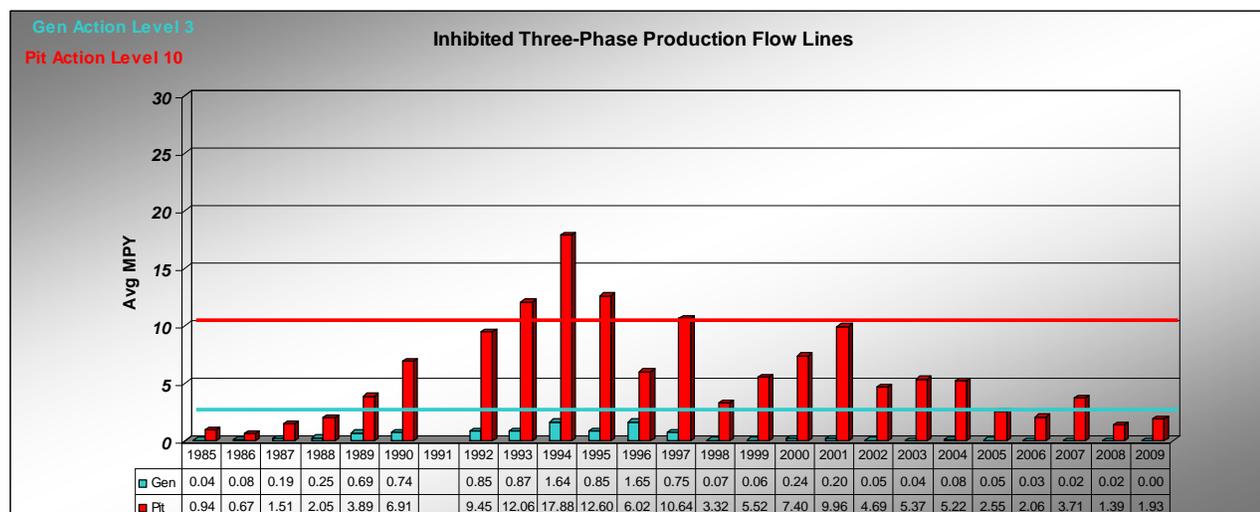
Figure 1. Inhibited Three-Phase Production Flow Line Coupons – general and pitting corrosion rates by year.

Three-phase Production Flow Lines: The monitoring data summarized in Tables 1 and 2 and presented in Figure 1 suggest that general corrosion is under control. The data presented in Tables 1 and 2 and in Figure 1 include corrosion coupon data from the wet oil line system from CPF3 to CPF1 and CPF2.

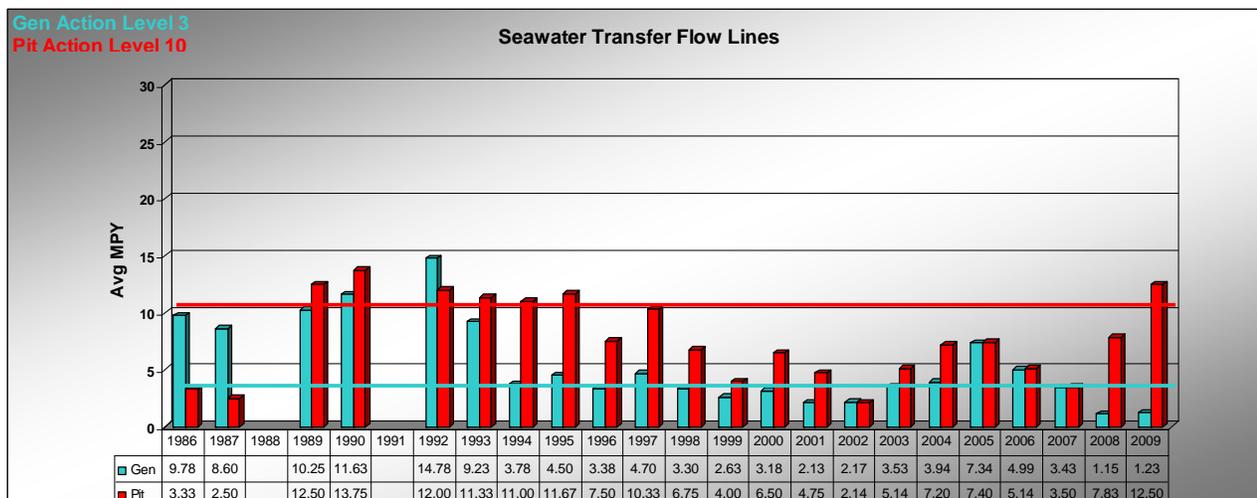
Figure 2. Seawater Transfer Flow Line Coupons – general and pitting corrosion rates by year.

Seawater Transfer Flow Lines: The monitoring data summarized in Tables 1 and 2 and presented in Figure 2, show the average corrosion rates for the SW flow line coupons. Average general corrosion rates are below threshold and pitting rates exceed the threshold and mitigation measures are being pursued. Biocide concentration is currently at 1000 ppm following weekly maintenance pigging. There are two coupon locations on the SW system, one at the STP and one on the SW line that supplies Alpine. The STP coupon on the SW discharge had an average pitting corrosion rate of 17 mpy. The Alpine line coupon at CPF2 had an average pitting corrosion rate of 3 mpy.

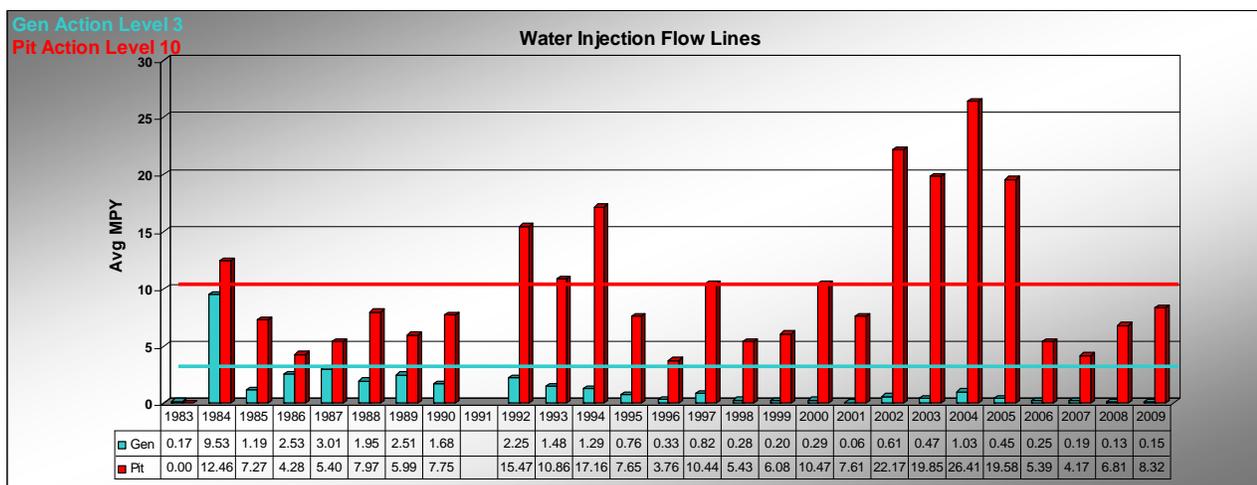
Figure 3. Water Injection Flow Line Coupons – general and pitting corrosion rates by year.

Water Injection Flow lines: The monitoring data summarized in Tables 1 and 2 are presented in Figure 3. Increased pigging and biocide have brought the WI flow lines coupon pitting rates under control. Since SW and PW commingling were suspended at CPF2 in 2005, pitting rates have been reduced markedly. Coupon results are used to prioritize inspection efforts. Additional chemical injection systems have been installed on individual lines at CPF1 and CPF2. Better cleaning pig styles have been deployed and alternate pigging technology is under evaluation. These lines also benefit from the weekly biocide treatment of the sand jet systems. Data from the coupon locations installed in water injection flow line drill site manifold headers during 2007, 2008 and 2009 show higher pitting corrosion trends than in the main flow line, based on inspection results. These coupon locations are in non-piggable portions of the system and are subjected to solids as a result of pigging the WI lines. Recurring inspections in the CPF1 water injection flow lines that were treated with biocide after pigging for a year had only one increase in 2009.

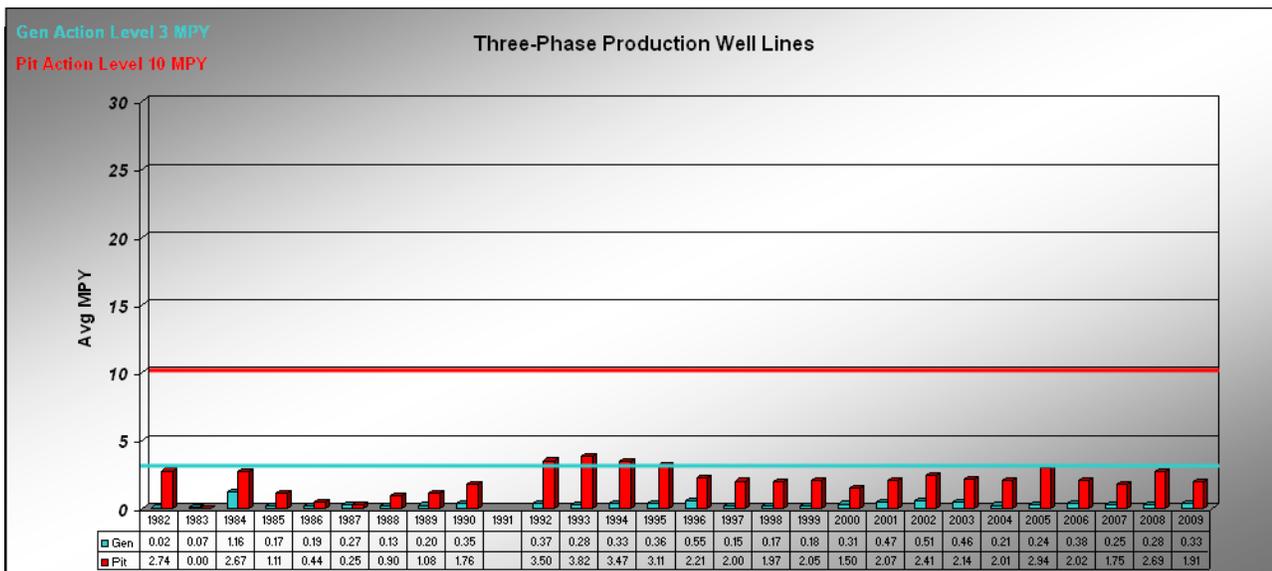
Figure 4. Three-Phase Production Well Line Coupons – general and pitting corrosion rates by year.

Three-phase Production Well Lines: While the monitoring data summarized in Tables 1 and 2 and presented in Figures 4 and 5 suggest that corrosion rates are below targets, inspection data indicate that pipe wall corrosion rates are higher. For three-phase production, coupons monitor free flowing fluid and have not shown the predominant, under-deposit corrosion mechanism.

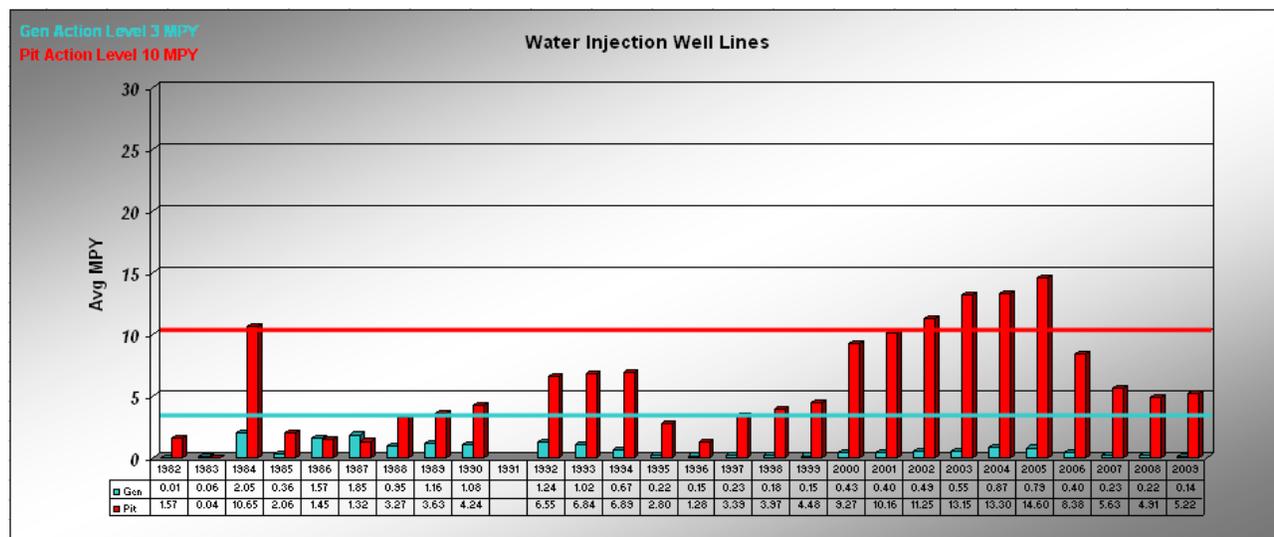
Figure 5. Water Injection Well Line Coupons – general and pitting corrosion rates by year.

Water Injection Well Lines: As discussed in section B.1.a, below, the well line inspection data on water injectors show that there are a significant number of corrosion related repairs. The water feeding this system is treated at the facilities with biocide and is discussed under Figure 3 - Water Injection Flow Line Coupons. We believe that increased velocities from decreasing the riser and well line diameters are contributing to the decrease in coupon corrosion rates.

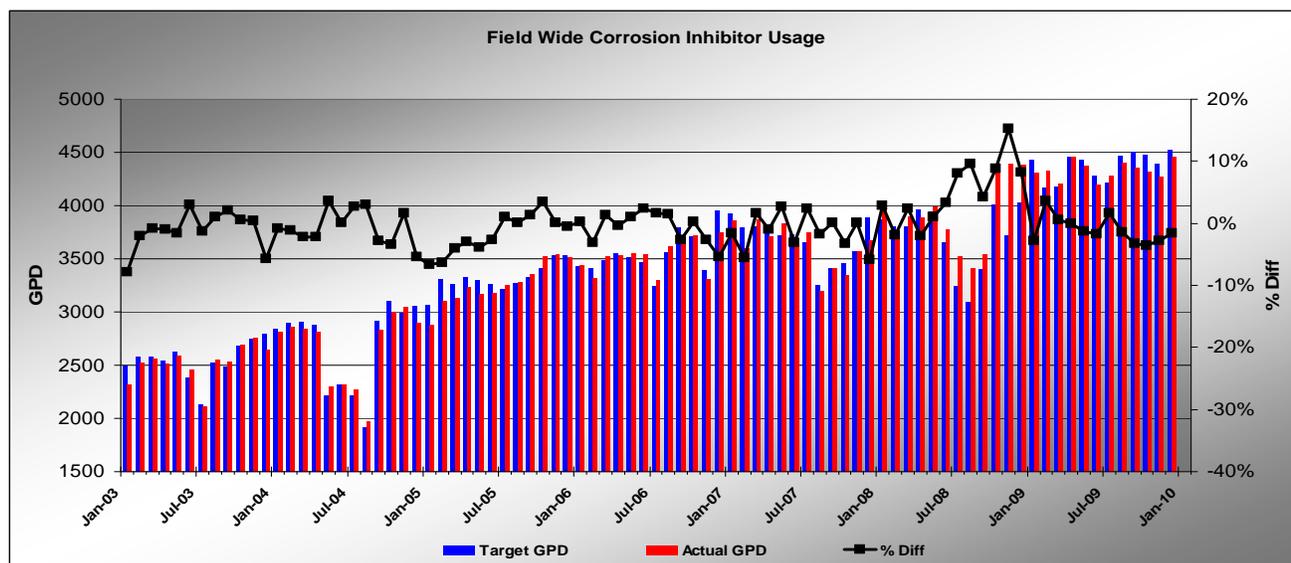
Figure 6. Field-wide Corrosion Inhibitor Use.

Figure 6 shows the actual number of gallons of CI pumped per day, the recommended (target) number of gallons per day and the percent difference between the two. The average deviation for the year was -1%. CI use has increased since 2003 because of higher water cuts and solids. Fluctuations in 2009 were caused mainly by temperature swings that changed production rates and subsequent target CI volumes.

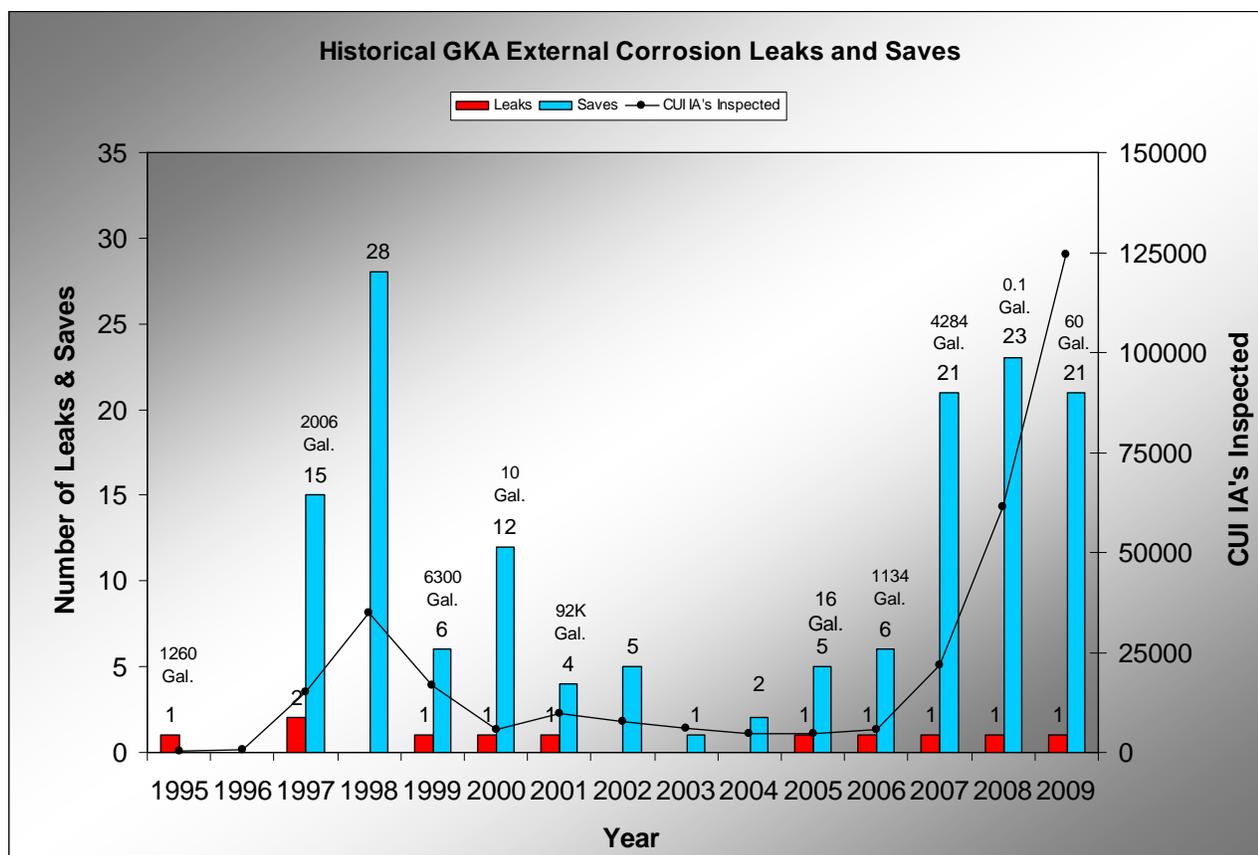
Figure 10. Leaks, saves, number of CUI IA's inspected with TRT, and volumes of leaks by year.

Figures 8, 9, and 10 above show the number of leaks and the volumes of leaks as a function of time. Figure 8 depicts the leaks caused by internal corrosion for the well lines. Figure 9 depicts the leaks caused by internal corrosion for the flow lines. Figure 10 shows the leaks caused by external corrosion for flow lines, well lines, and below-grade piping locations.

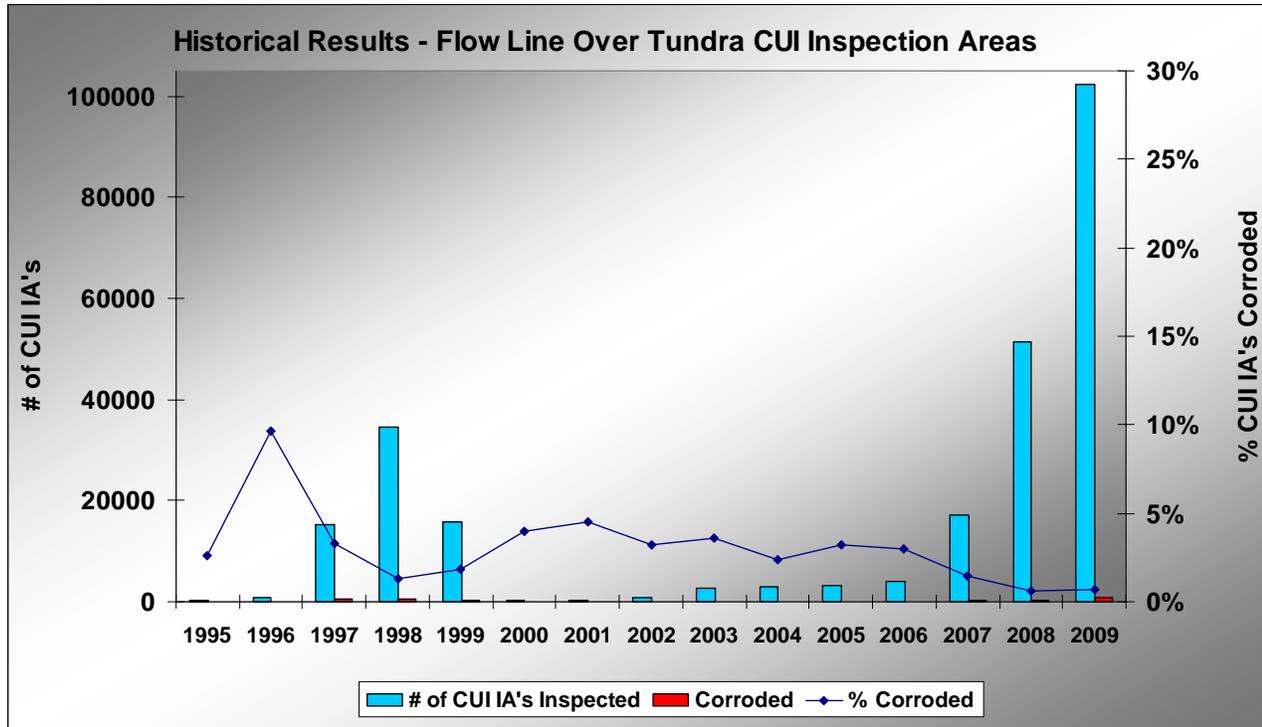
Figure 11. Summary of Flow Line Over-Tundra (off-pad) CUI IA's

Figure 11 illustrates the latest results from the external corrosion inspection program. The 2002 through 2006 values include recur follow-up inspections and clean-up of locations missed or not properly documented during the original base line effort. The increased inspection effort starting in 2007 is representative of our field-wide recur inspection to re-evaluate all locations on a five-year inspection interval. The 2008 and 2009 data include ILI results on flow lines. The 2009 data include IR results on well lines.

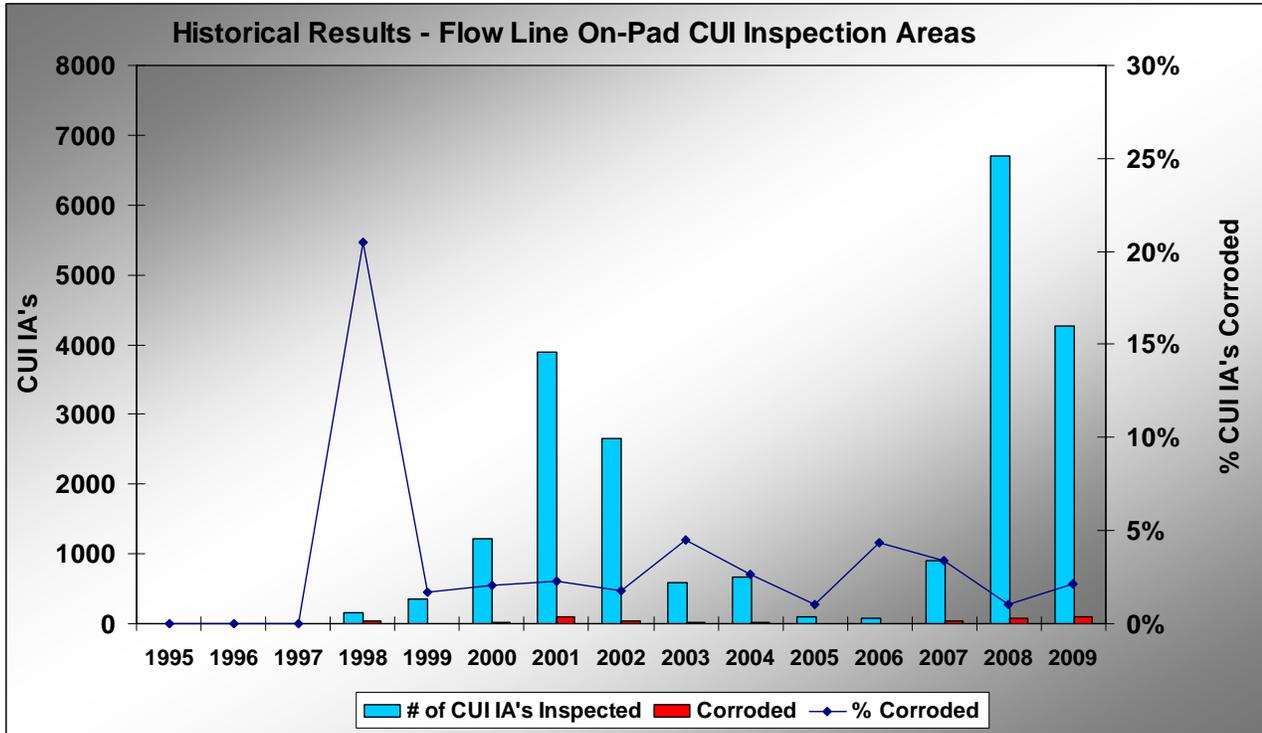
Figure 12. Summary of Flow Line On-Pad CUI IA's

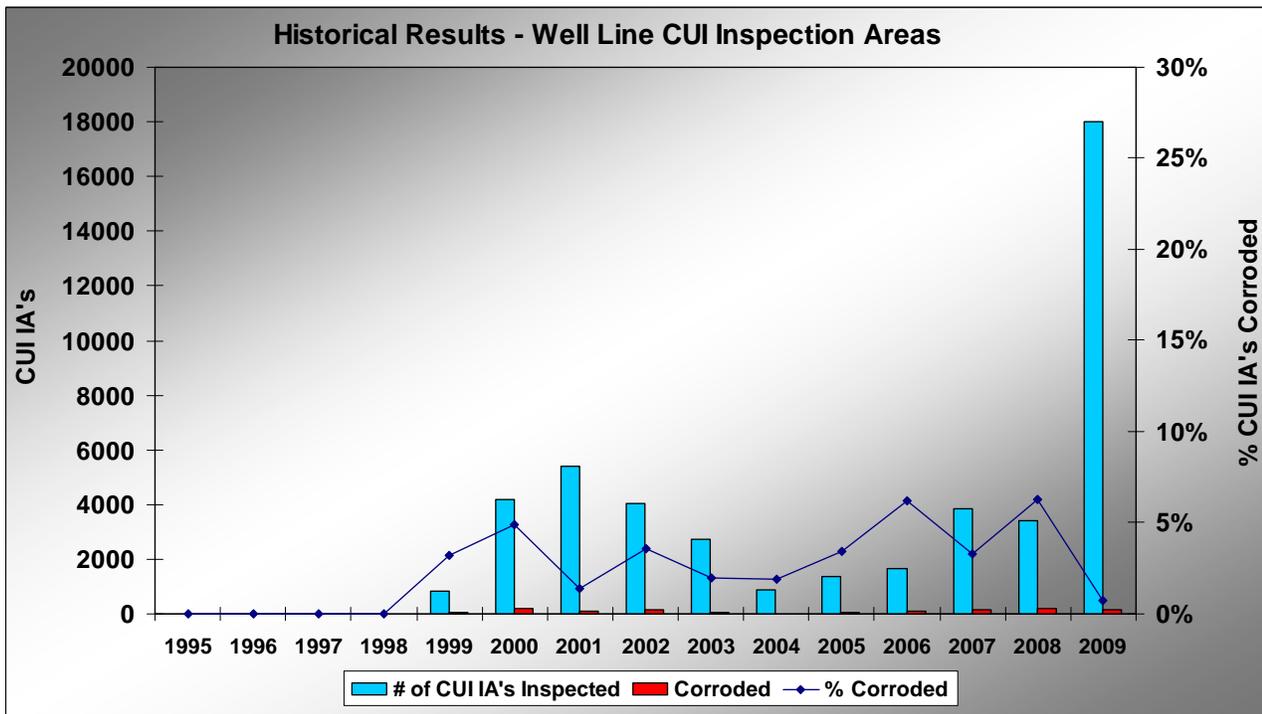
Figure 13. Summary of Well Line CUI IA's

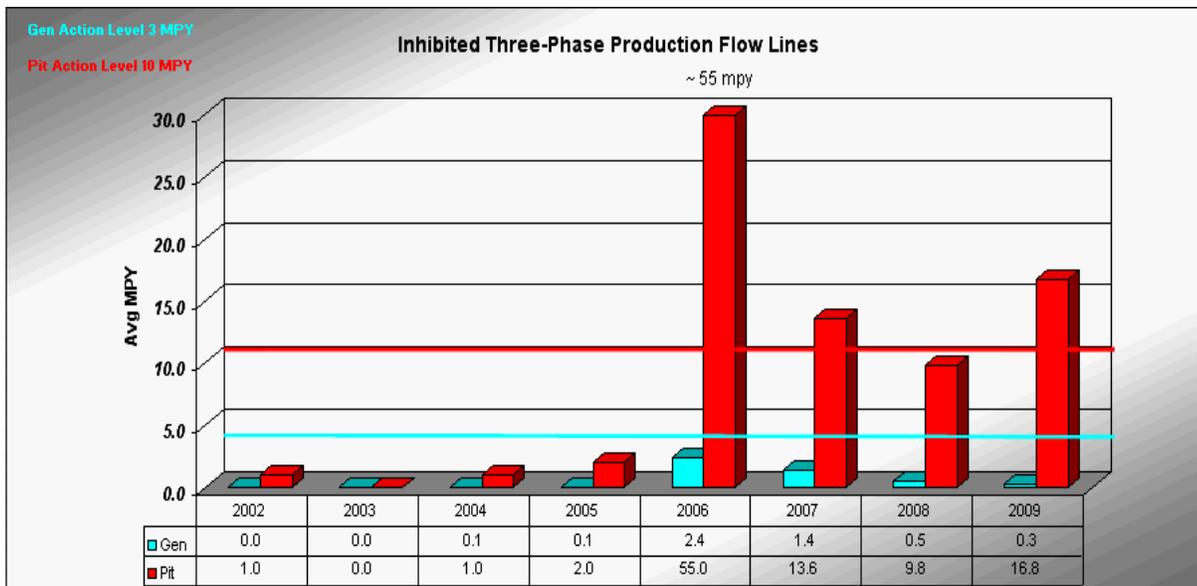
Figure 14. WNS Three-phase Production Flow Line Coupons – general and pitting corrosion rates by year.

Three-phase Production Flow Lines: The monitoring data summarized in Tables 8 and 9 and presented in Figure 14 show that the average pitting corrosion rates in 2009 are above the action level. In response to the coupon and probe corrosion rates, adjustments were made to the CI dosage on the CD1, CD2, and CD3 production lines. In addition, a new CI formulation was implemented in 2009, and a test of another formulation was started.

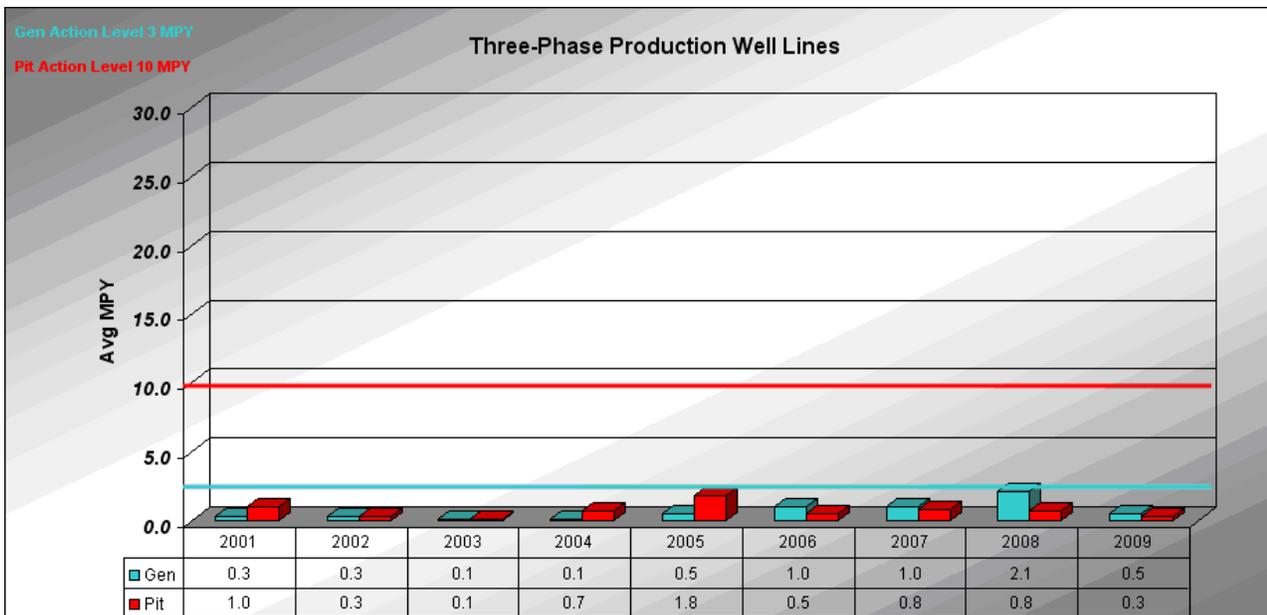
Figure 15. WNS Three-phase Production Well Line Coupons – general and pitting corrosion rates by year.

Three-phase Production Well Lines: The monitoring data summarized in Tables 8 and 9 and presented in Figure 15 show that corrosion rates have not approached action levels in the well lines. Inspection data, discussed in section B.1.a, indicate that significant corrosion damage has not taken place in these lines.

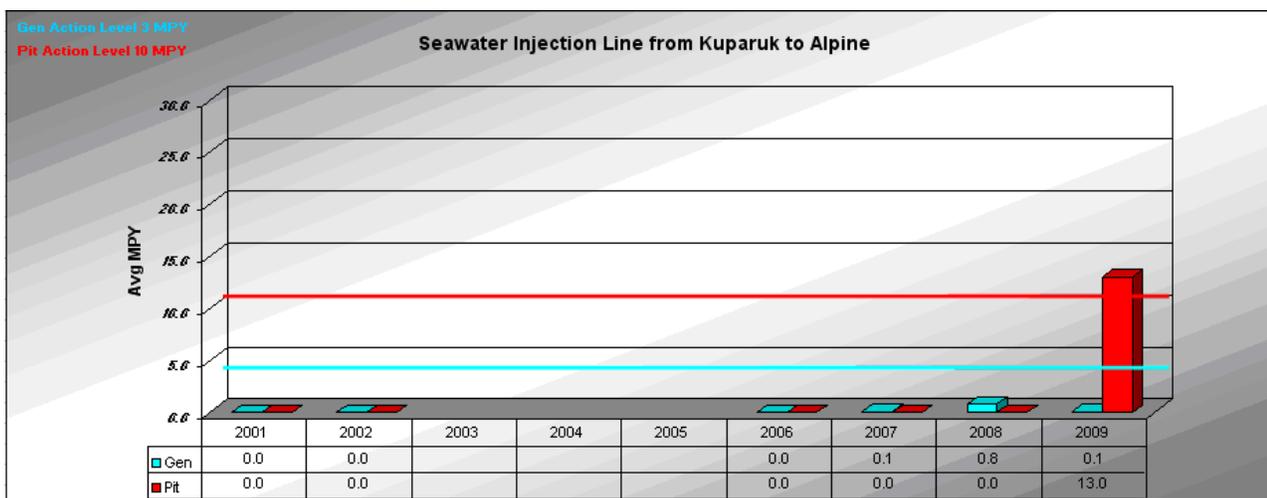
Figure 16. WNS Sea Water Line Coupons – general and pitting corrosion rates by year.

Sea Water Line from Kuparuk to Alpine: The monitoring data summarized in Tables 8 and 9, and presented in Figure 16 above, show the average corrosion rates for the SW flow line coupons. Data collection resumed in 2006 when a coupon fitting was installed to replace the previous location which was obstructed by piping reconfiguration. The pit indicated by the 2009 data is higher than target. Follow-up inspections to in-line inspection indicate no damage in this line.

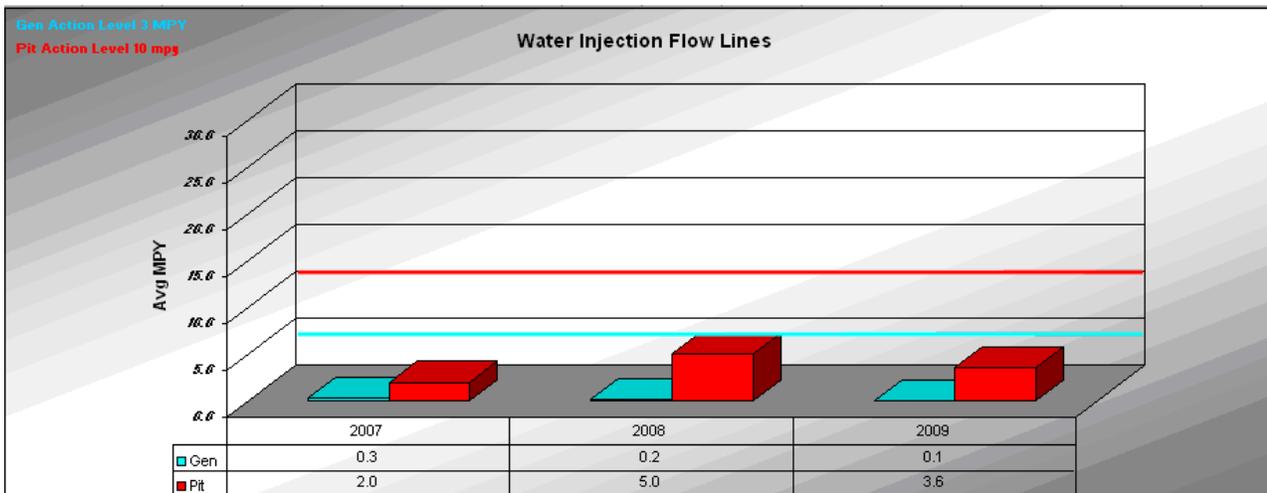
Figure 17. WNS Water Injection Flow Line Coupons – general and pitting corrosion rates by year.

Infield Water Injection Flow lines: The monitoring data summarized in Tables 8 and 9 show the average corrosion rates for the infield WI flow line coupons. Average coupon and probe general and pitting corrosion rates for these lines are minimal. Inspection data, discussed in section B.1.b, indicate that significant corrosion damage has not taken place in these lines.

The infield WI lines are treated with a weekly biocide treatment and monthly maintenance pigging. New cleaning pig styles are being used. In addition, produced water lines are treated with corrosion inhibitor.

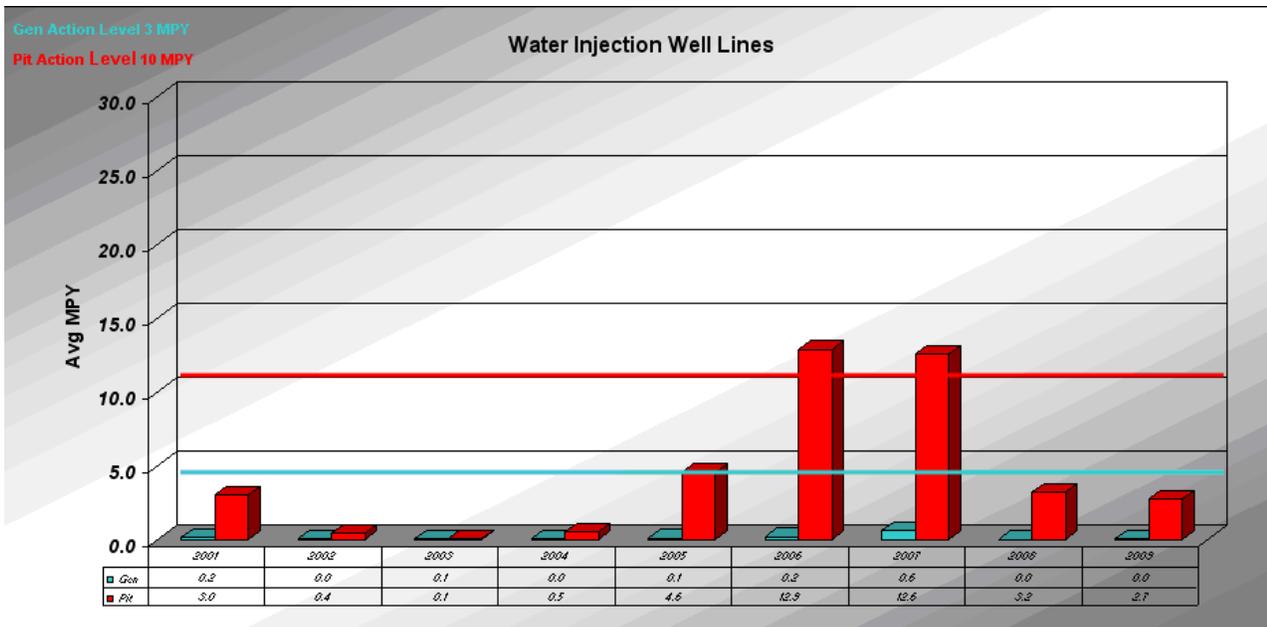
Figure 18. WNS Water Injection Well Line Coupons – general and pitting corrosion rates by year.

Water Injection Well Lines: The monitoring data summarized in Tables 8 and 9 and presented in Figure 18 show that pitting corrosion rates are below the action level. Inspection data presented in Section B.1.a indicate no damage in these lines.
