Unalakleet '09 November Flood

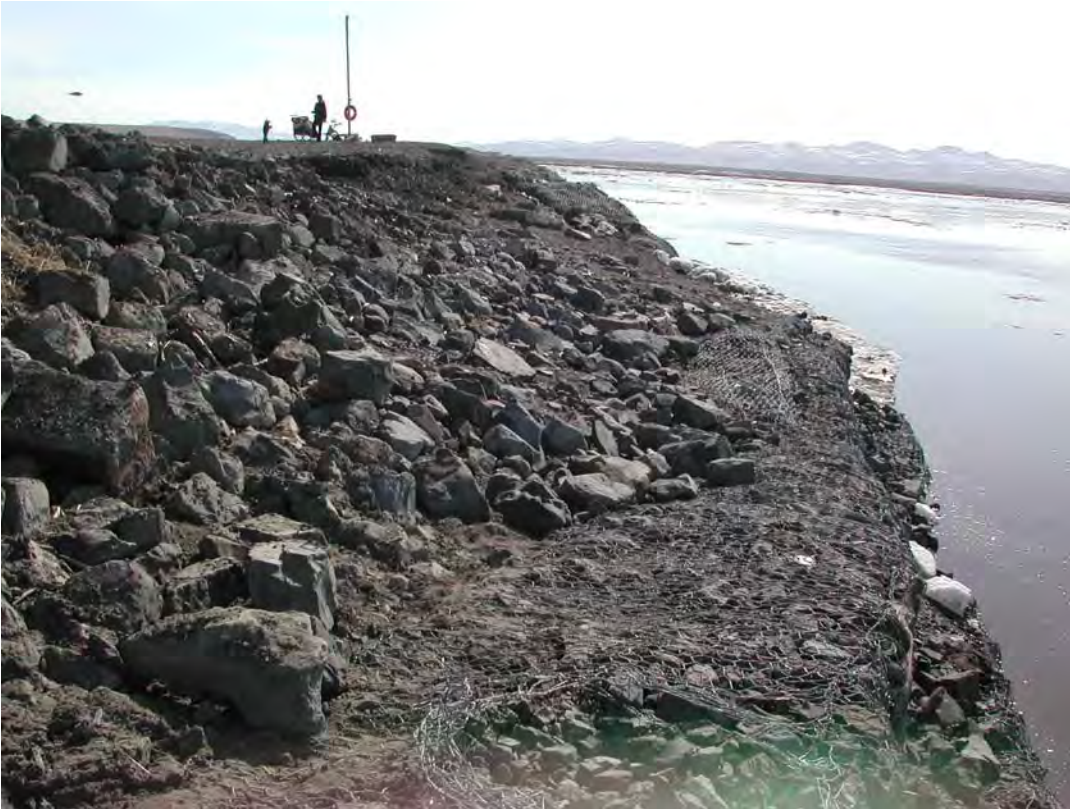
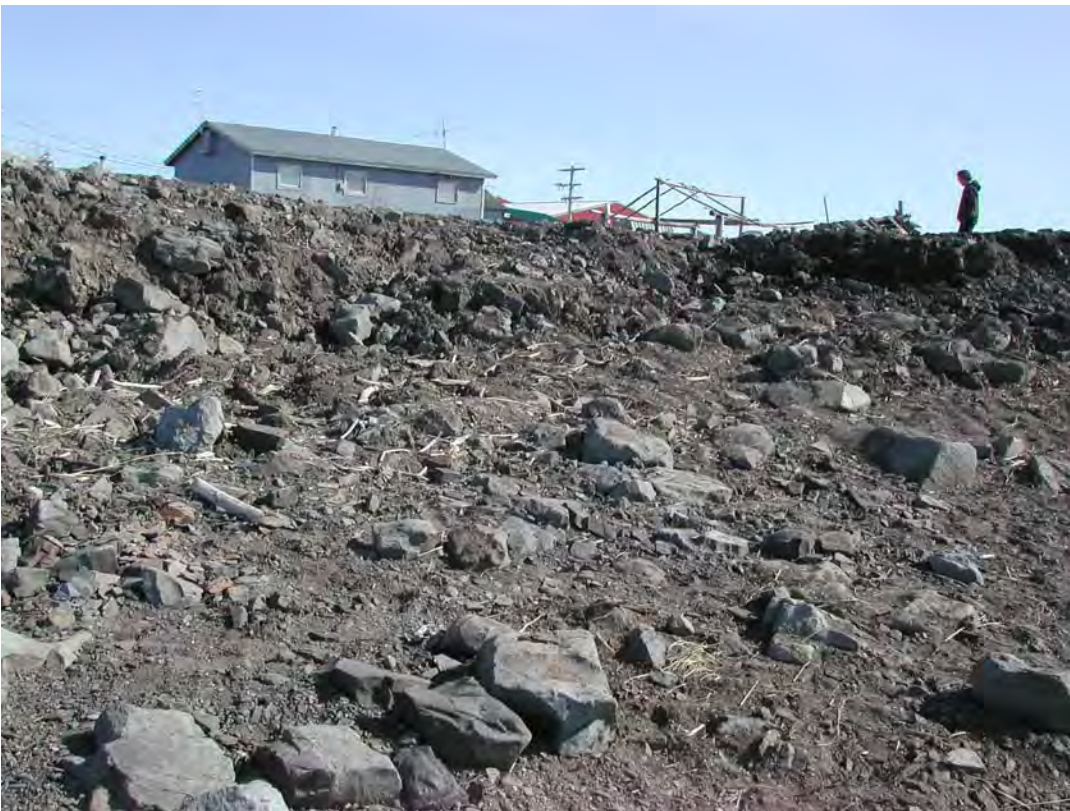
The top photo shows the gabions dropping from the undermining and the bottom photo shows the erosion that followed the collapse with a home and the fish plant in the background.

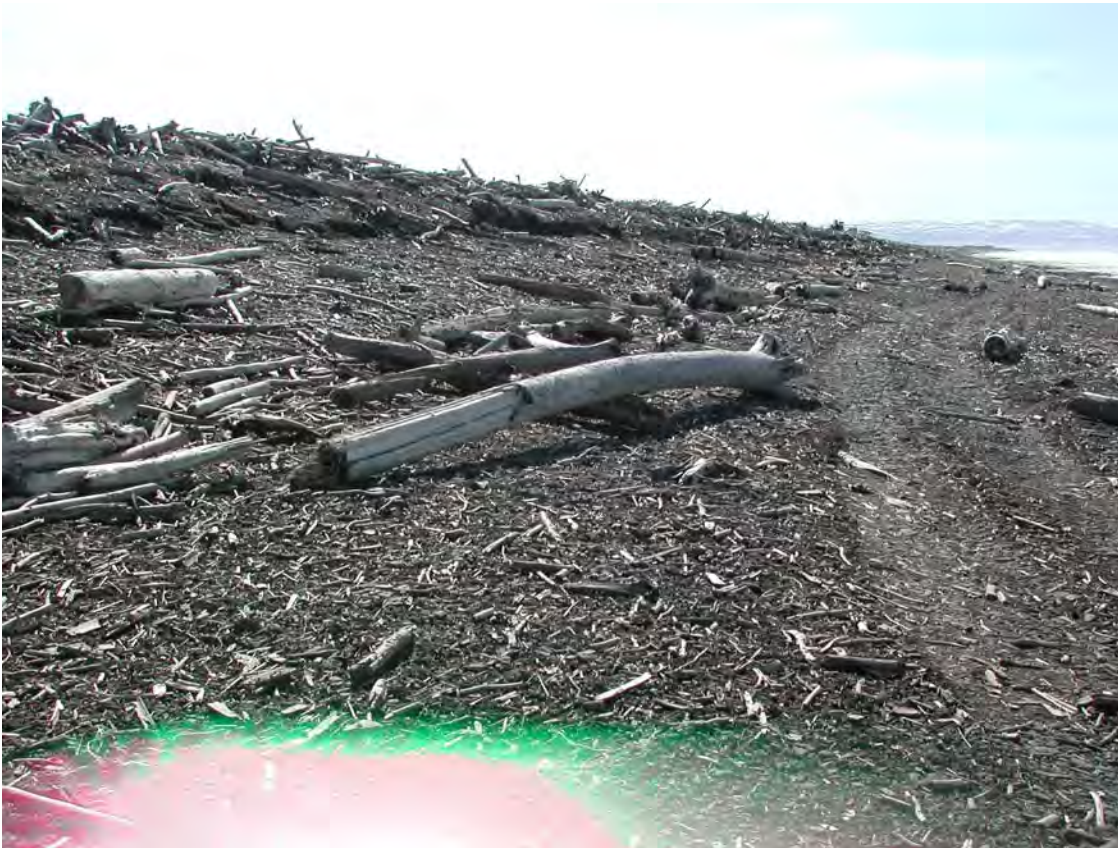
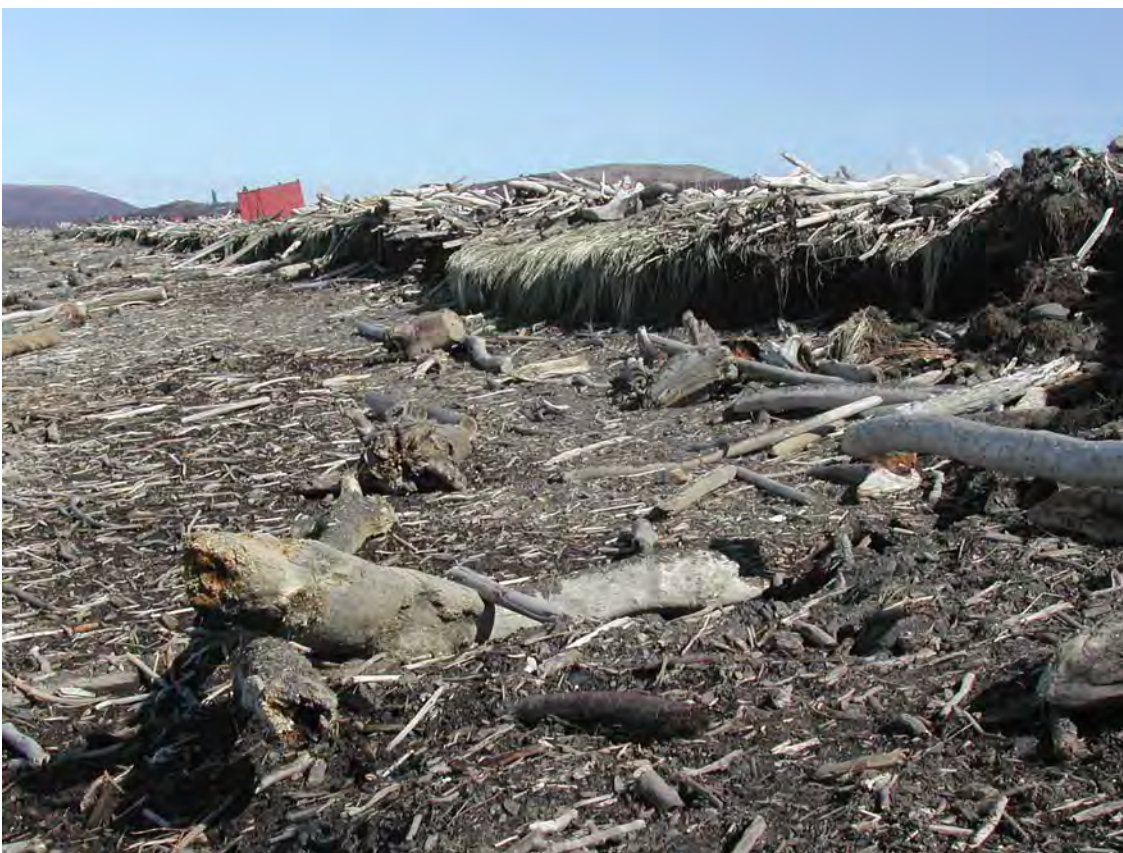
We discussed this in past workshops where the State DNR allowed too much beach mining. The top photo shows a section of beach not mined and just adjacent to that section below is a section where it was mined heavily by a local contractor. We stressed over and over the concern of erosion threatening our water and power lines.

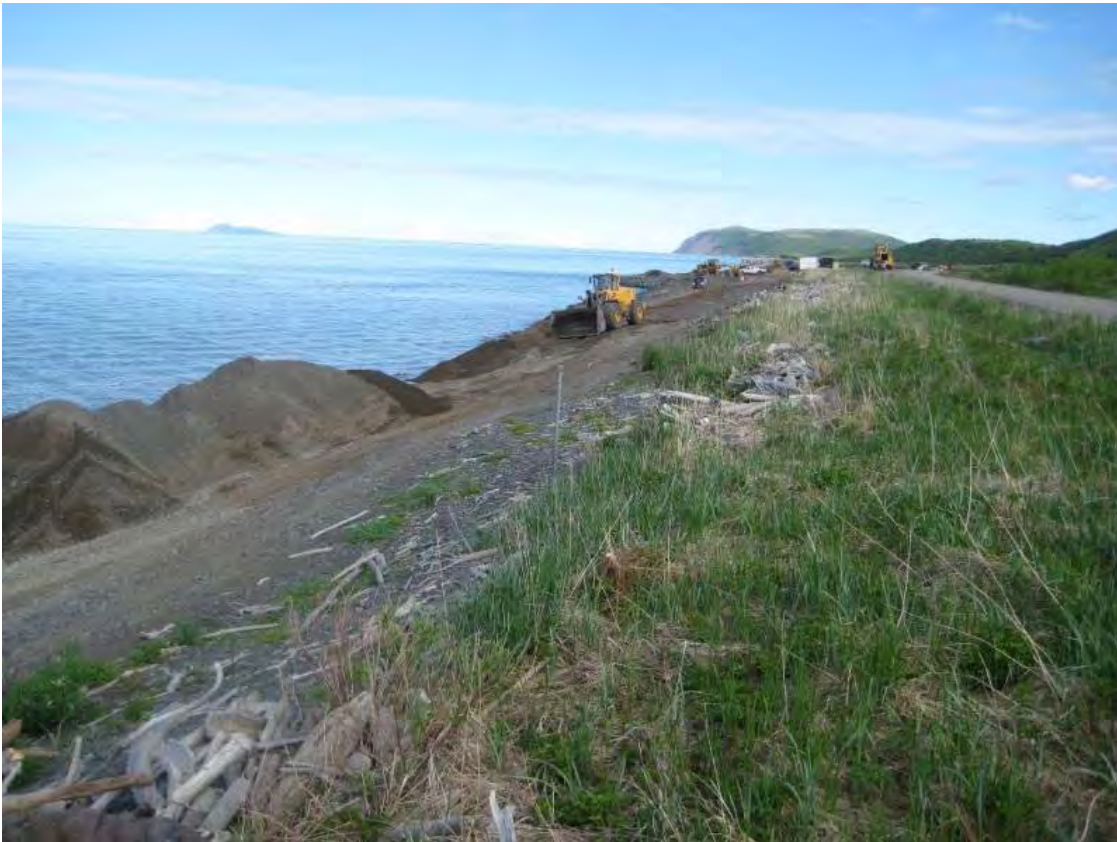
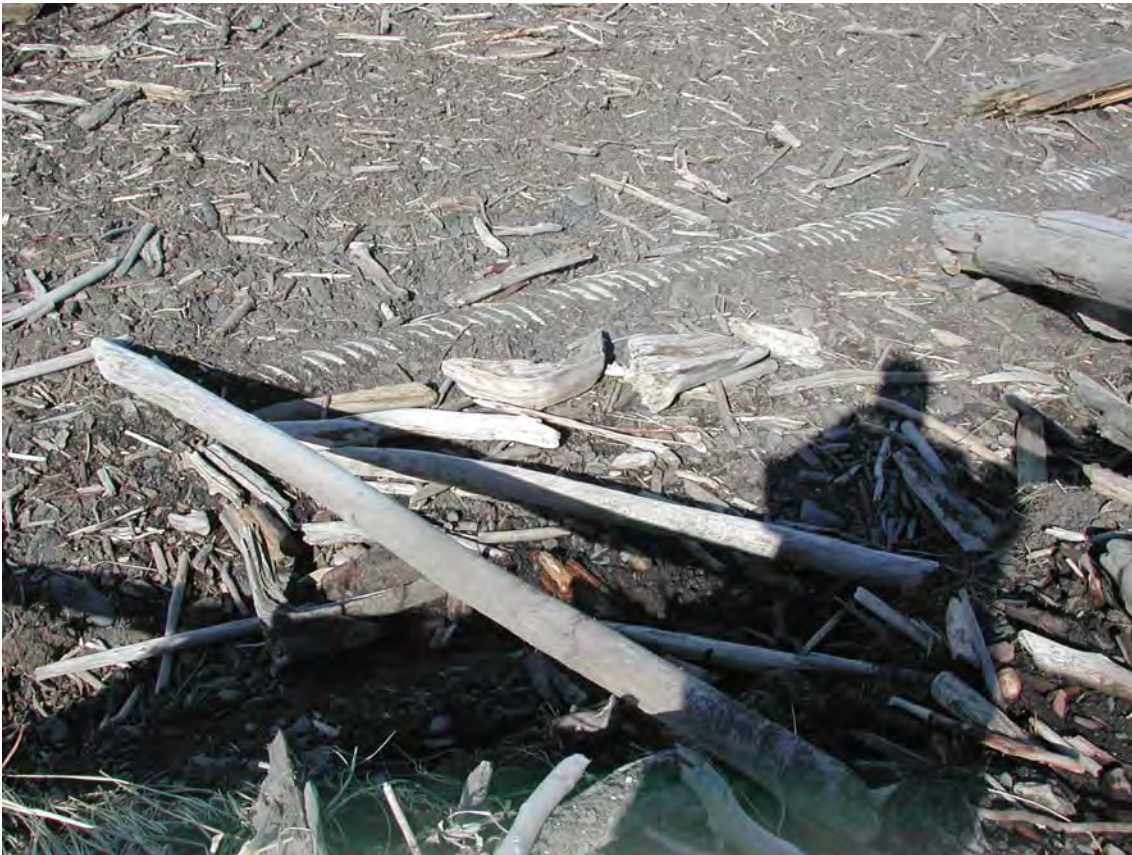
The top photo shows the mining that was opposed by the tribe and village corporation and the photo below shows the active, live waterline that feeds the community. The pipe just below the bucket in the photo above shows where the waterline is situated underneath.

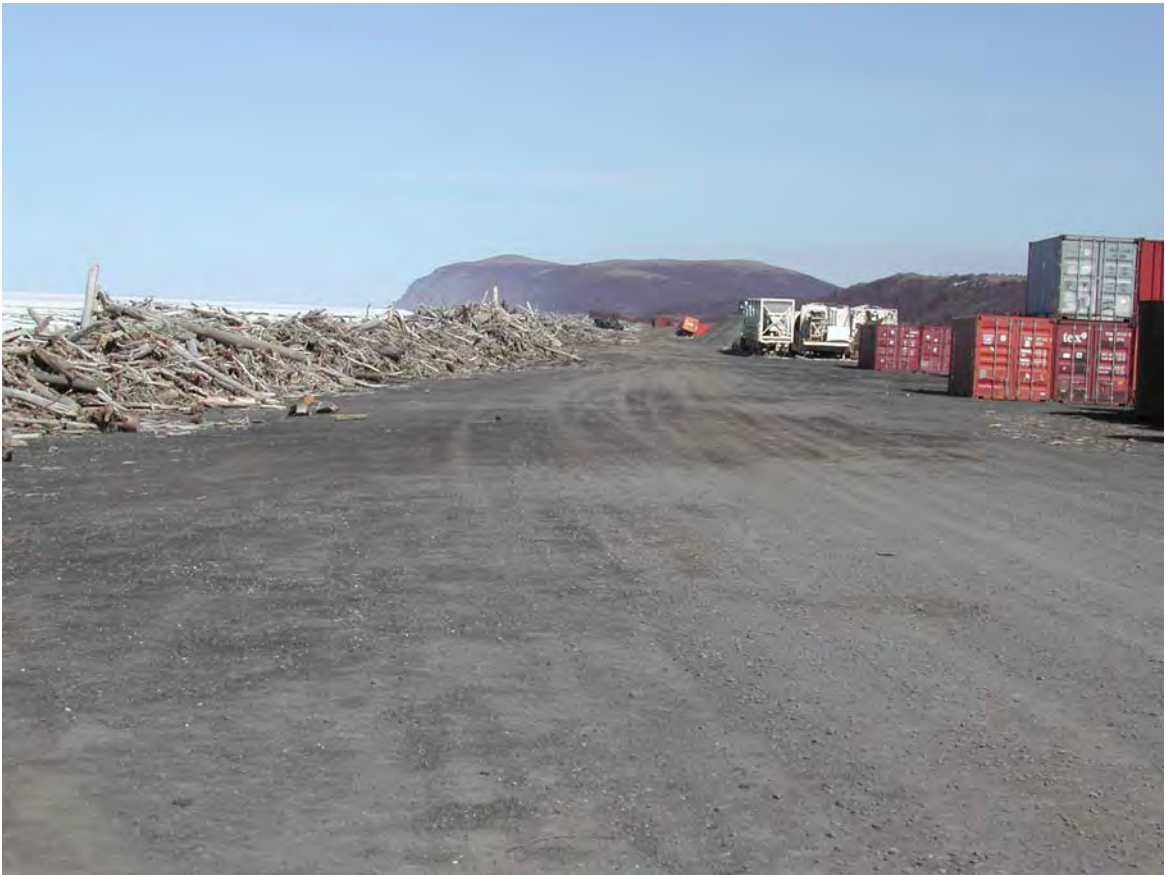
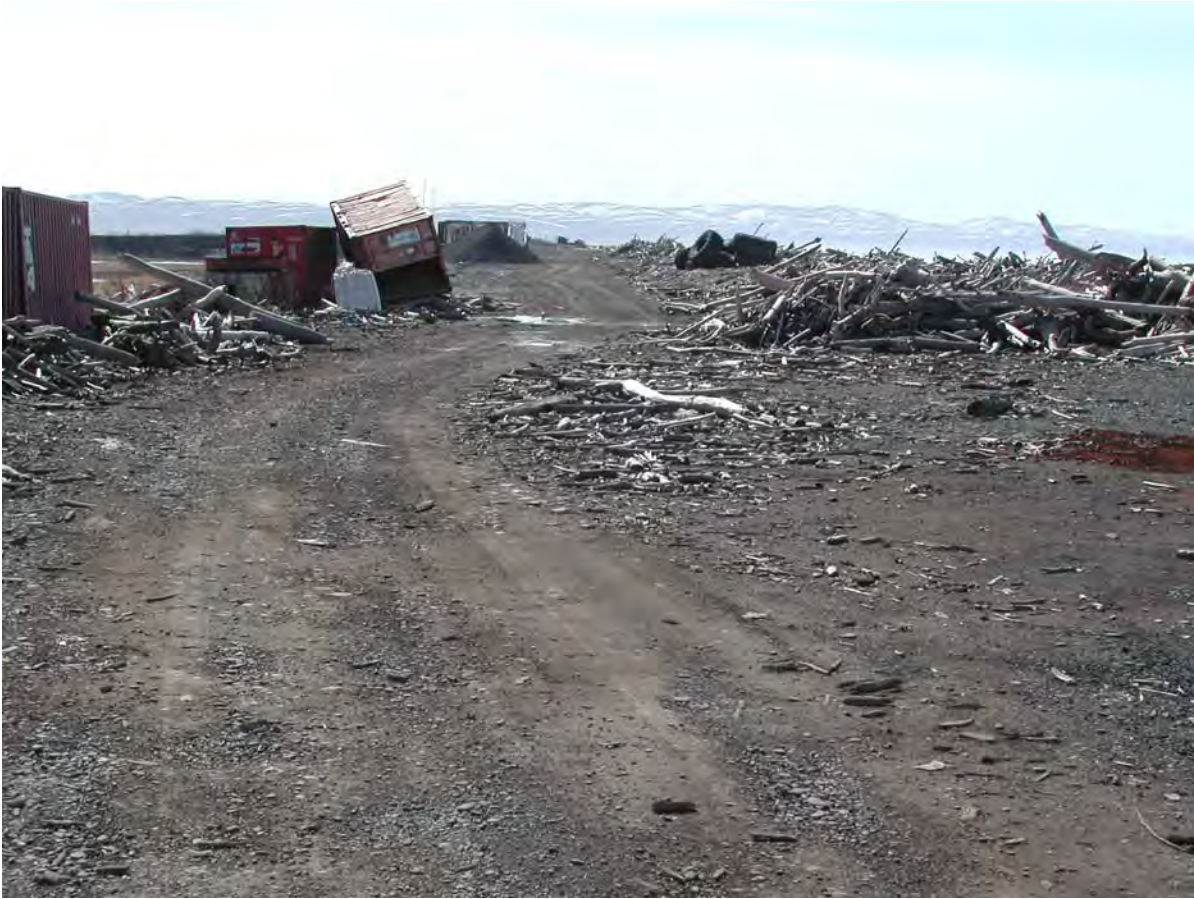
The logs littered the access road to the water source and the photo below show the damage done to storage vans.

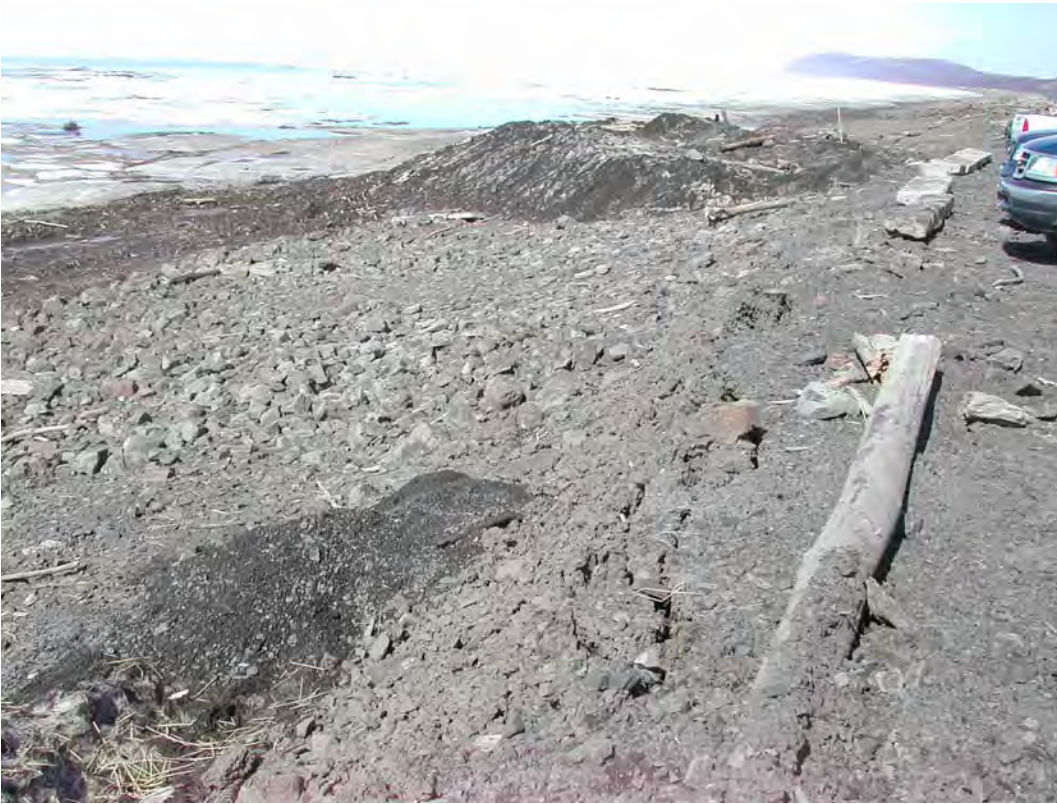
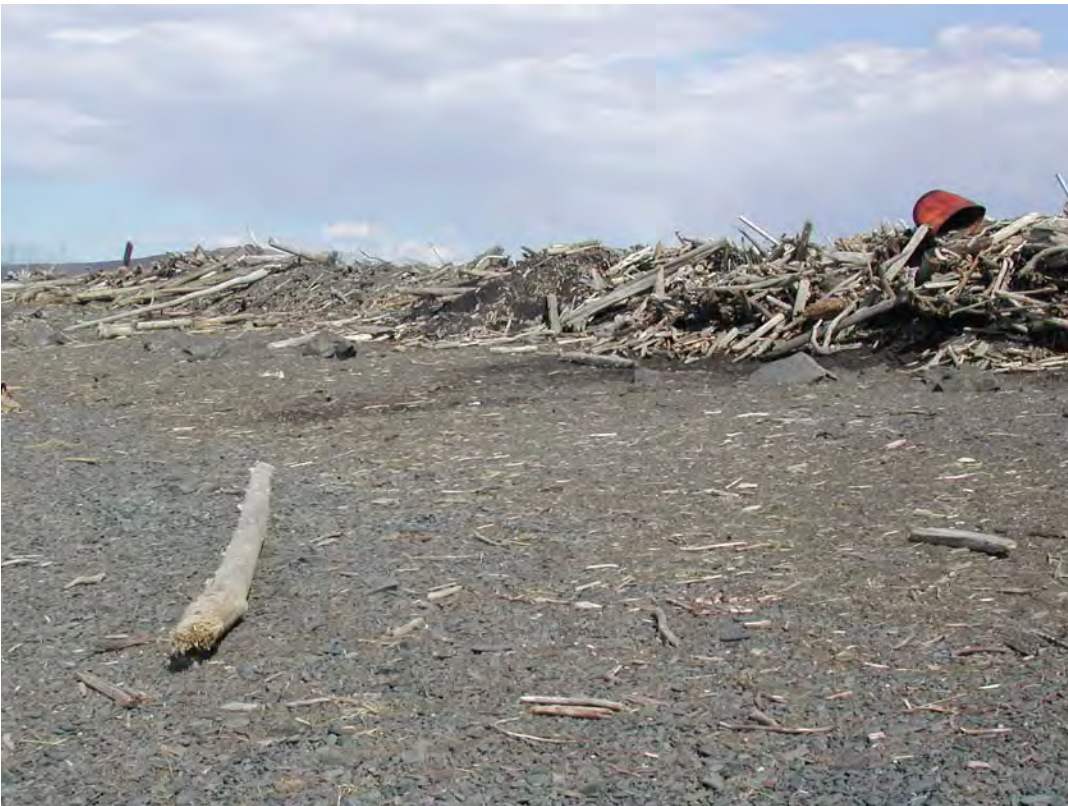
The photo above shows the DOT erosion project, the southern section was damaged less but this northern section looks like a bomb blew it up. The photo below shows the airport fence beaten down by logs. To say no, to little damage was done in the November flood not knowing what was under the ice was definitely an understatement. The process needs to allow communities to file for disaster declaration due to extenuating circumstances such as this one. No one can assess the damage until it can be seen.
